01 Independent Quality Assurance: Pre-Pour Inspection

[REDACTED]
[REDACTED] 3217, Australia
[REDACTED]
[REDACTED]

[REDACTED] 2023

Slab on ground

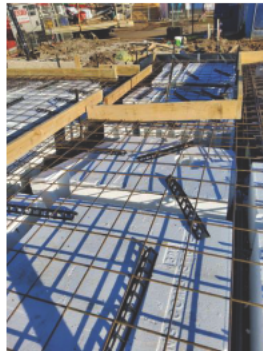
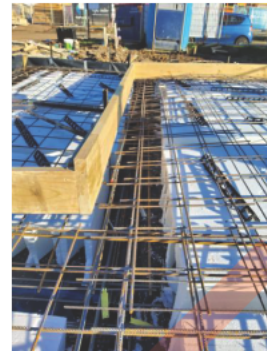
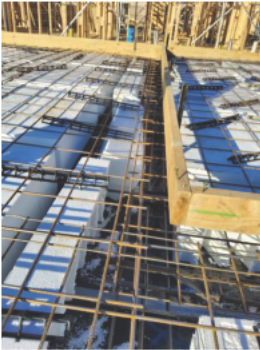
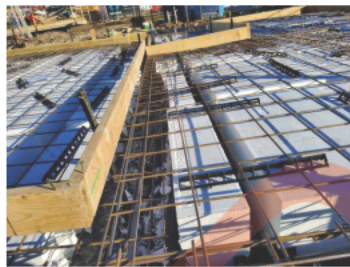
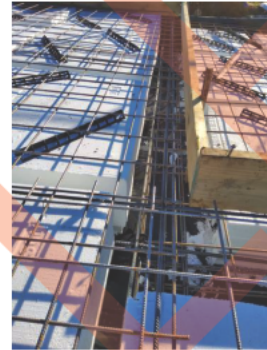
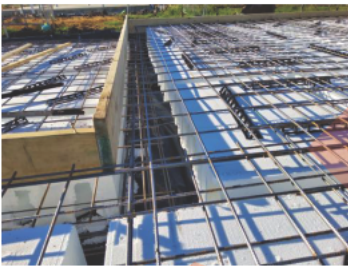
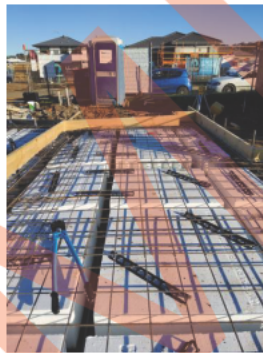
1.2.2: Fabric consistent height

SIGNIFICANT DEFECT REMAINS

Highlighted areas where mesh sags.

Refer to the National Construction Code of Australia in particular section 3.2.3.2 Steel reinforcement:

Reinforcement is designed to be in a particular place so as to add strength or to control cracking of the concrete. A displacement from its intended location could make a significant difference to the life or serviceability of the structure.

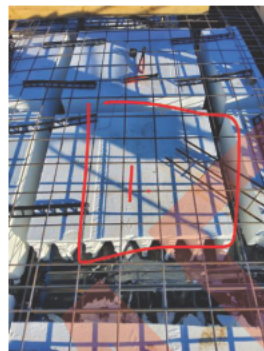
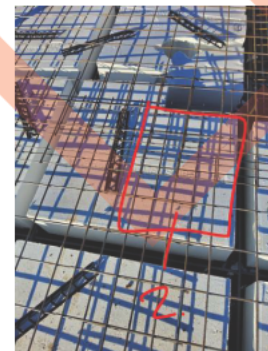
+1.2.4: Bar chairs

DEFECT REMAINS

Refer to the National Construction Code of Australia in particular section 3.2.3.2 Steel reinforcement:

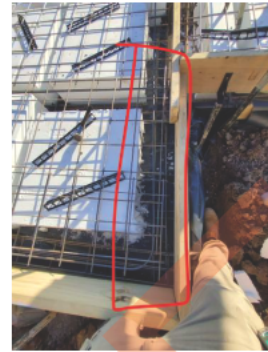
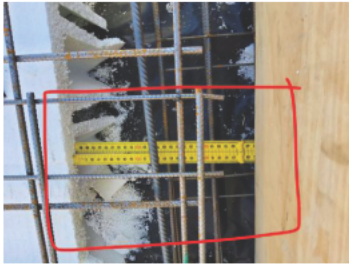
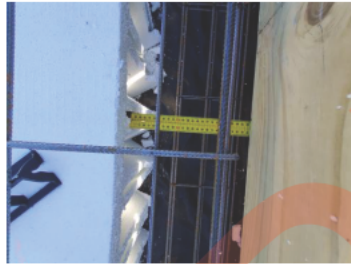
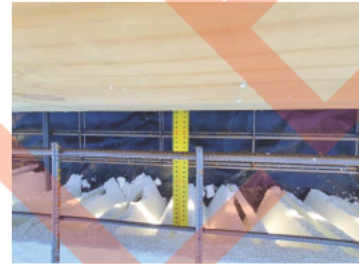
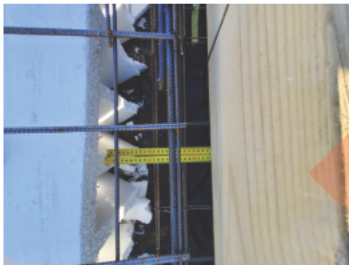
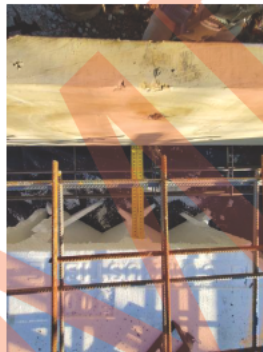
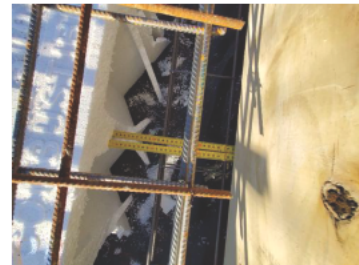
1.3.1: Stem width as per Engineer's requirements

SIGNIFICANT DEFECT REMAINS

Stem width exceeds 220mm and additional bar is required.

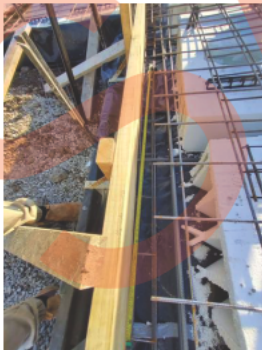
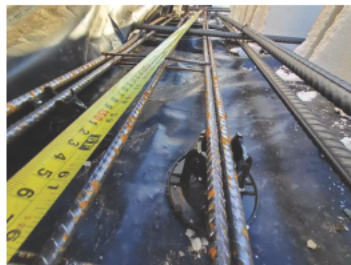
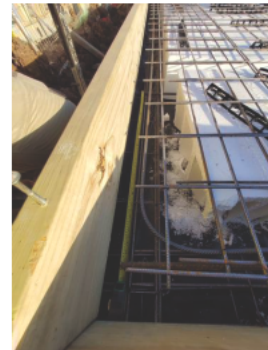
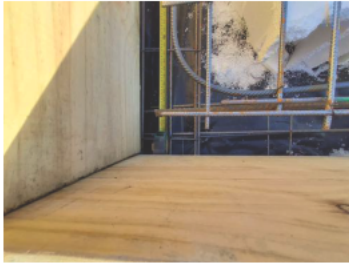
1.3.2: External beam reinforcement cover (side/bottom)

SIGNIFICANT DEFECT REMAINS

All bottom trench mesh not supported chair spacing exceeds 800mm centres and not as per engineers design.

ALL REINFORCEMENT SHALL BE FIRMLY SUPPORTED ON INSULATED STEEL, PLASTIC OR CONCRETE CHAIRS GENERALLY AT NOT GREATER THAN 900 CENTRES BOTH WAYS. RODS SHALL BE TIED AT ALTERNATE INTERSECTIONS.

There are coverage issues at the marked up location that don't meet AS 2870 part 5.3.2(a): "Reinforcement in rafts and slabs shall be 40 mm to unprotected ground, 40 mm to external exposure, 30 mm to a membrane in contact with the ground, and 20 mm to an internal surface."

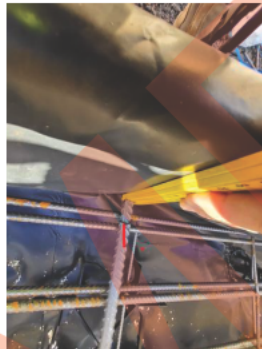
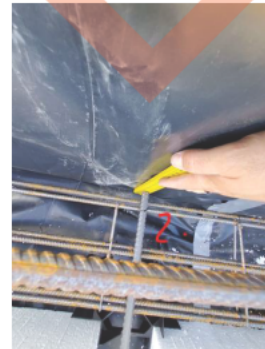
1.4.1: Internal beam reinforcement cover (side/bottom cover on steel)

DEFECT REMAINS

Bottom internal rib bar side cover not achieved.

"(d) Footings and slabs-on-ground must have concrete cover between the outermost edge of the reinforcement (including ligatures, tie wire etc.) and the surface of the concrete of not less than the following:

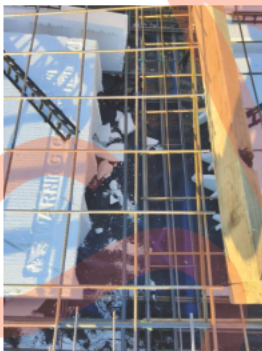
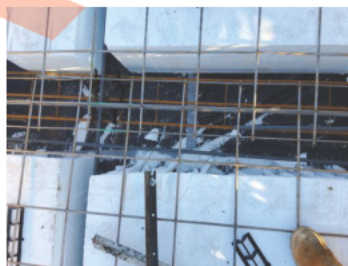
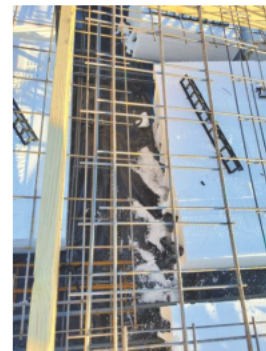
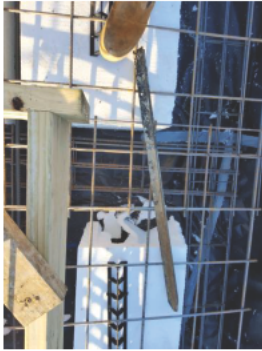
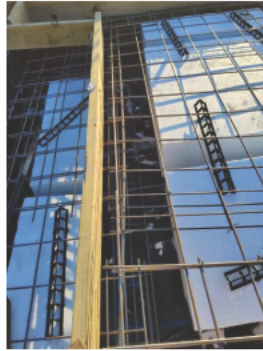
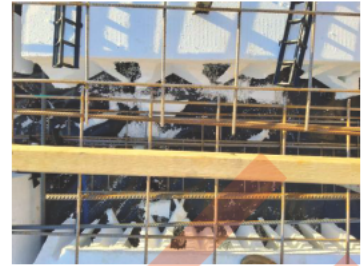
1.6.1: Waffle set out as per engineer's drawings

DEFECT REMAINS

Waffle pod debris throughout ribs and beams.

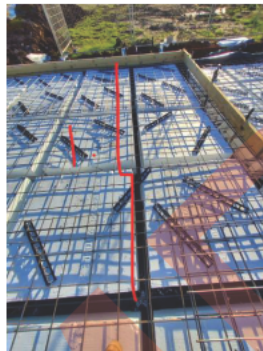
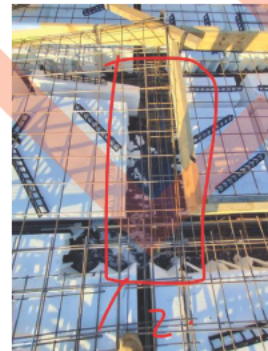
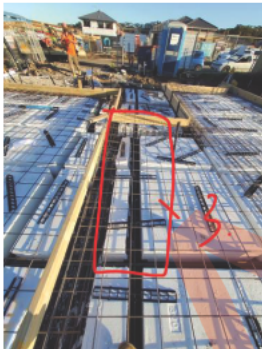
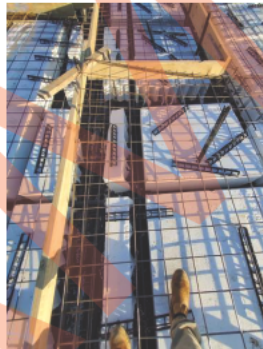
1.6.2: Waffle pods in position?

Highlighted ribs not aligned.

DEFECT REMAINS

As per Australian Standard 2870 - Residential slabs and footings, part 6.4.6:
"Reinforcement and void formers shall be fixed in position prior to concreting by means of proprietary spacers, bar chairs with bases, ligatures or other appropriate fixings so as to achieve the required reinforcement position and concrete covers."

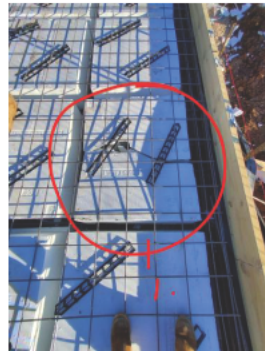
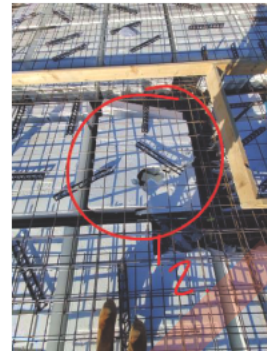
DEFECT REMAINS

Highlighted pods damaged.

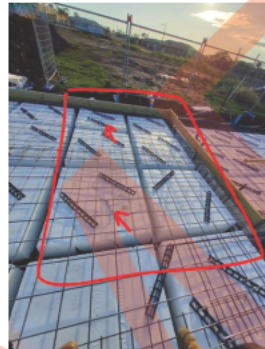
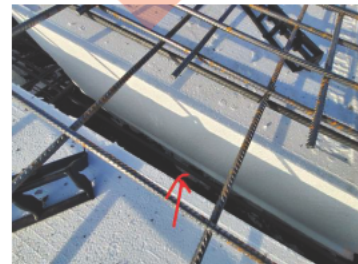
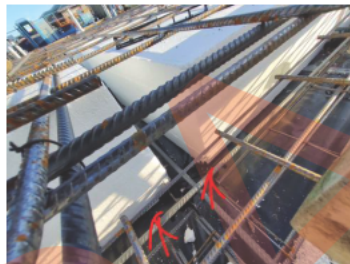
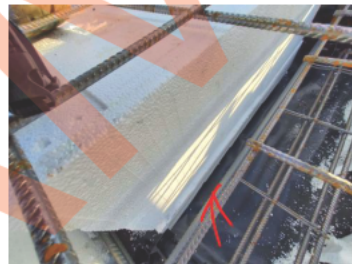
The Rear alfresco step down has been cut back too far into the home theatre by approximately 1200mm, the builder has stacked loose and cut pods, some pods have been damaged due to not being supported properly, engineer to review and RBS to approve.

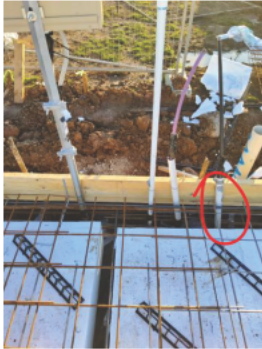
Photo 48

2.1.2: Water conduit/s installed and secure

DEFECT REMAINS

Not secured to boxing.

Water conduit not installed. As per section 5.6 of AS 2870-Residential slabs and footings "ADDITIONAL REQUIREMENTS FOR CLASSES M, H1, H2 AND E SITES" refer to the specific section 5.6 .4 Plumbing requirements:

"(e) Cold water pipes and heated or hot water pipes shall not be installed under a slab, unless the pipes are installed within a conduit so that if the pipe leaks water it will be noticed above the slab or outside the slab and will not leak unnoticed under the slab.

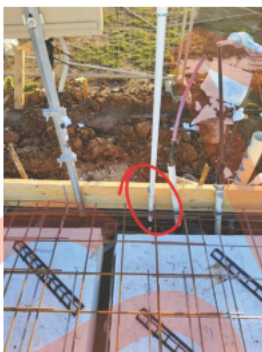
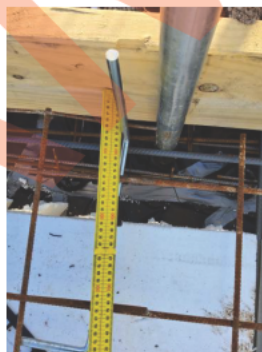
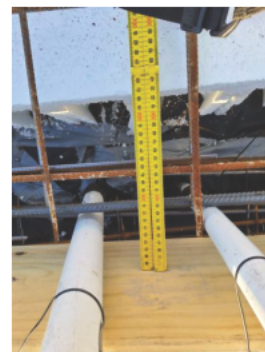
2.1.5: Phone conduit installed/stabilised

DEFECT REMAINS

Not fully secured to boxing.

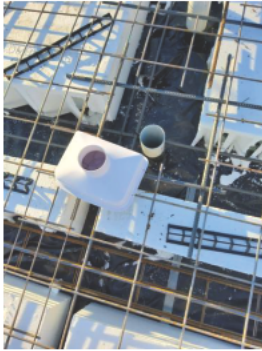
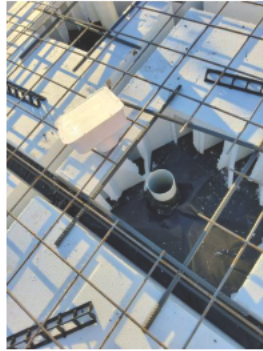
2.2.2: Smart pans installed

DEFECT REMAINS

Not installed.

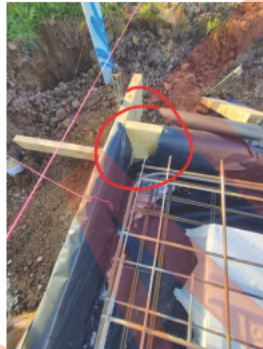
CLOSED OUT WHILST ONSITE

Cut/damaged vapour barrier to corner of porch

AS 2870-Residential slabs and footings. Part 5.3.3.4(a) of AS 2870 requires the vapour/damp proof membrane to be installed as per the below:
"The sheet shall be placed beneath the slab so that the bottom surface of the slab and beams, including internal beams, is entirely underlaid. The membrane shall extend under the edge beam to ground level;"

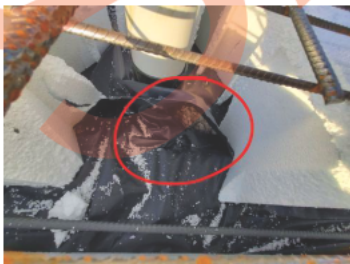
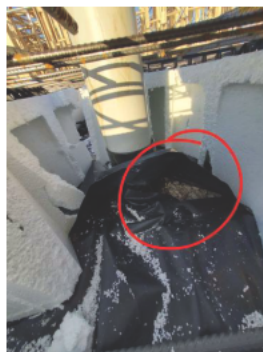
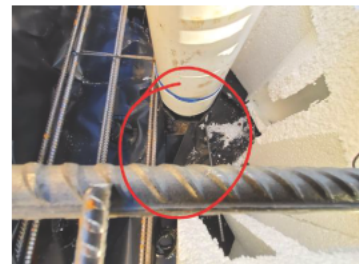
2.3.2: Taped at pipe penetrations

DEFECT REMAINS

Not taped around penetrations, base material visible.

Refer to the National Construction Code of Australia in particular section 3.2.2.6 Vapour barriers, (b) Installation; A vapour barrier must be installed as follows—:
“(ii) tape or seal with a close fitting sleeve around all service penetrations;”

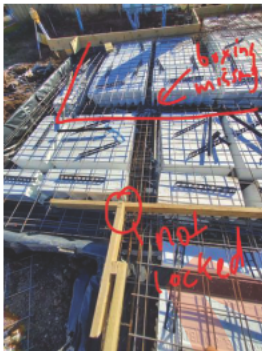
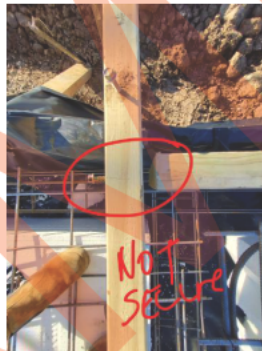
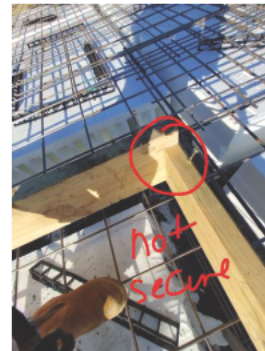
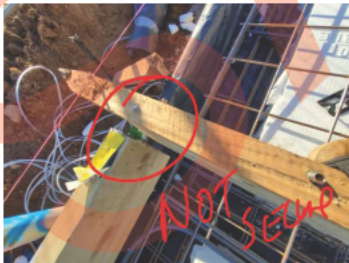
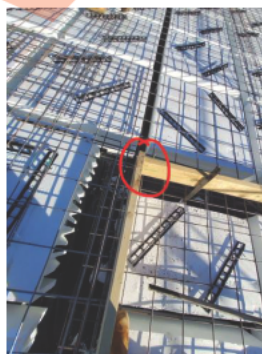
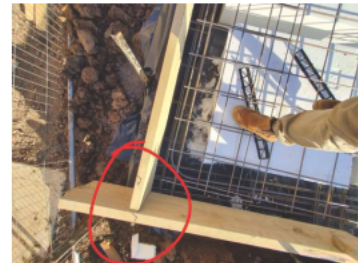
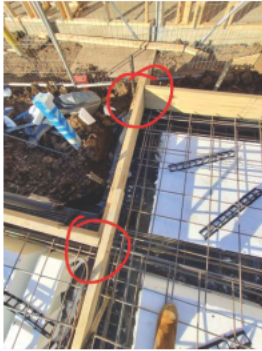
2.4.1: Dimension spot check

DEFECT REMAINS

At the time of the inspection the boxing was incomplete and not locked in, Builder to check all slab dimensions prior to pouring concrete.

Builder/Supervisor to review dimensions prior to pour

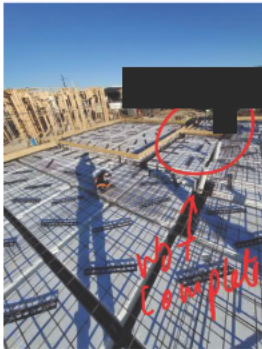
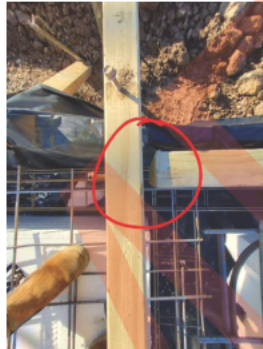
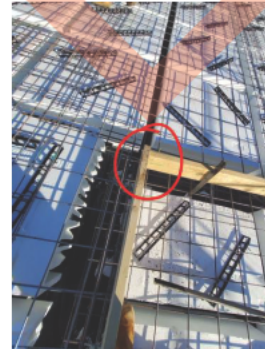
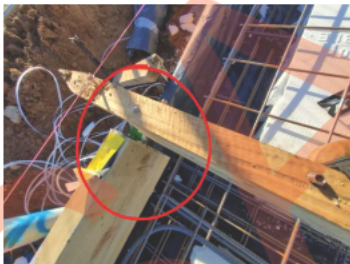
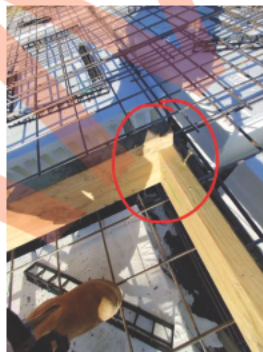
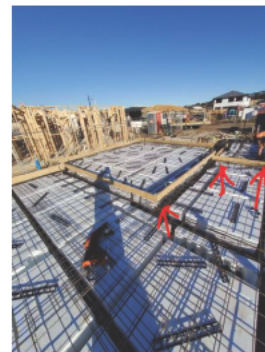
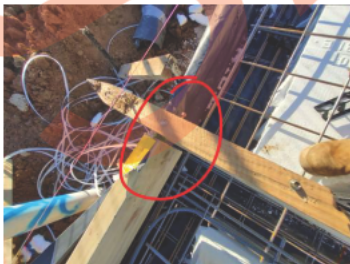
2.4.2: Sewer/waste approximate locations; Shower/s, Sewer stacks (2 storey), WC/s, Wall hung vanities

DEFECT REMAINS

At the time of the inspection the boxing was incomplete and not locked in, Builder to check all pipe/conduit locations prior to pouring concrete.

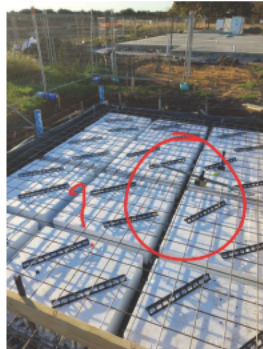
The Rear alfresco floor waste has not been installed as per the approved plan, Builder to discuss with client if not being installed for a variation to the design.
