## 01 Independent Quality Assurance: Post-Pour Inspection

01.2 Independent Quality Assurance: Post-pour / [REDACTED]

Flagged items	7
Inspection type	01.2 Independent Quality Assurance: Post-pour
Job Name	[REDACTED]
Client	[REDACTED]
Site Address	[REDACTED] Australia [REDACTED]
Inspection Date	[REDACTED] 2023
Footing description	Waffle raft
Inspection completed by	[REDACTED]
Weather	8:00am: 14°, Cloudy and windy with a shower in spots, Wind SW 32km/h, Wind Gusts 57km/h

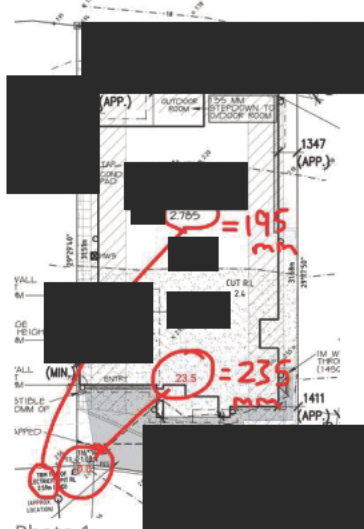
Photo 1

The finished floor level at the entry door compared to the electrical pit is equal to the maximum tolerance set out in the VBA's Guide to Standards and Tolerances however whilst completing the house levels survey there are areas that exceed this 0.0 datum therefore the house falls outside tolerance.

Some examples of high spots in the attached plan I.e +0.13 (=+13mm) from doorway. This example equals +53mm FFL.

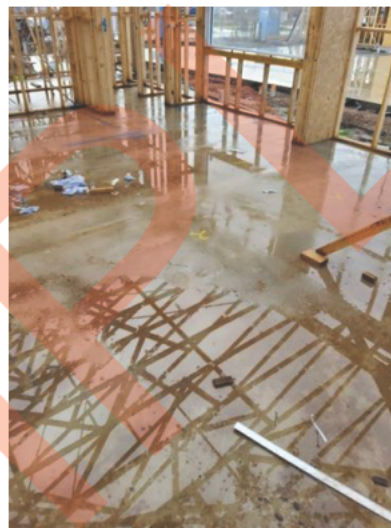
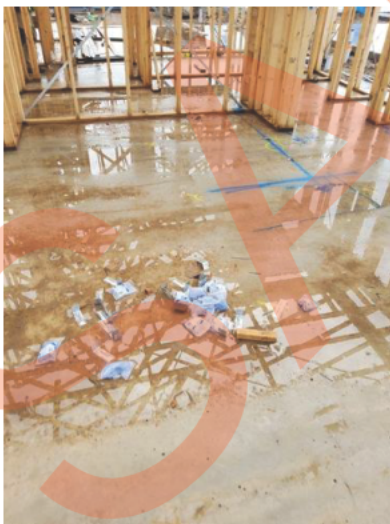
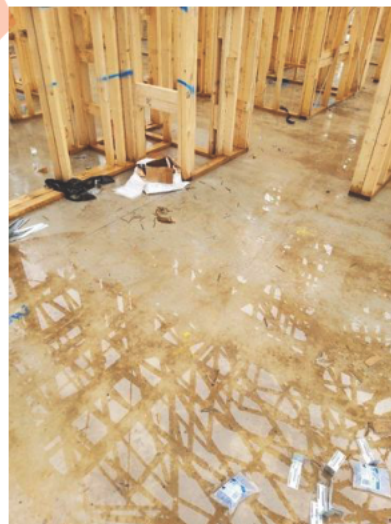
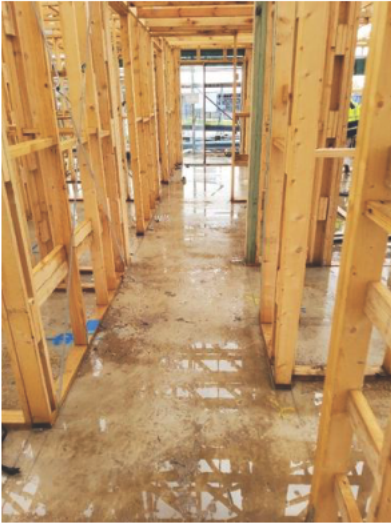
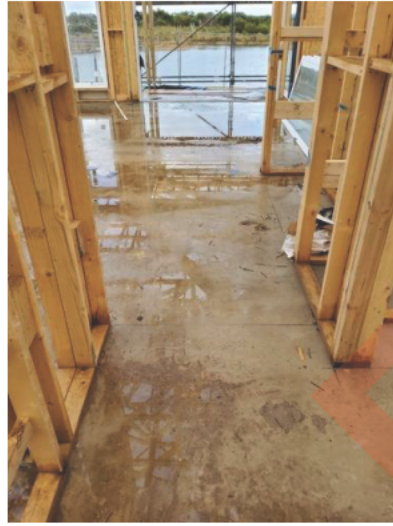
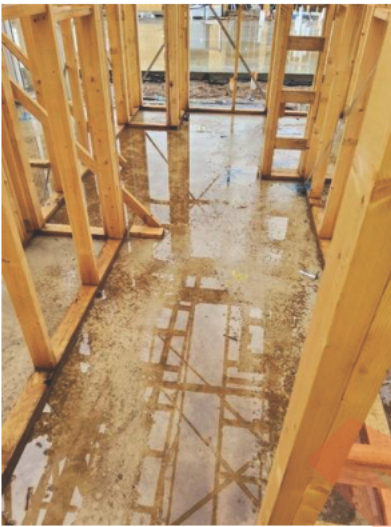
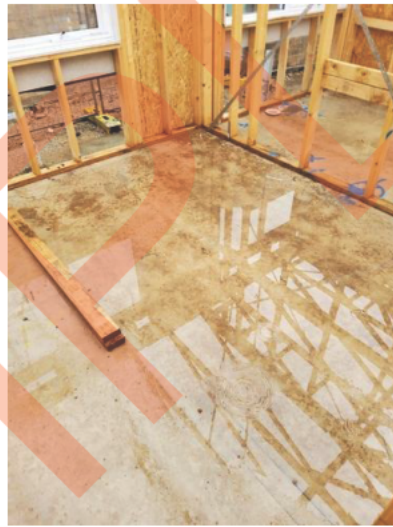
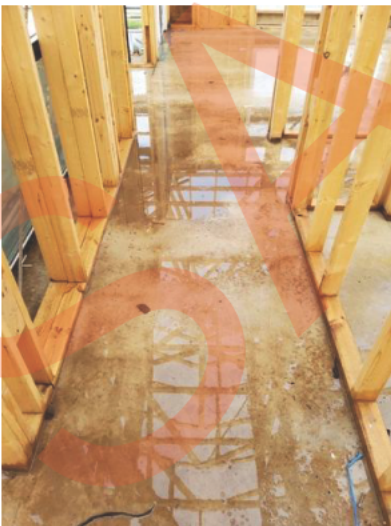
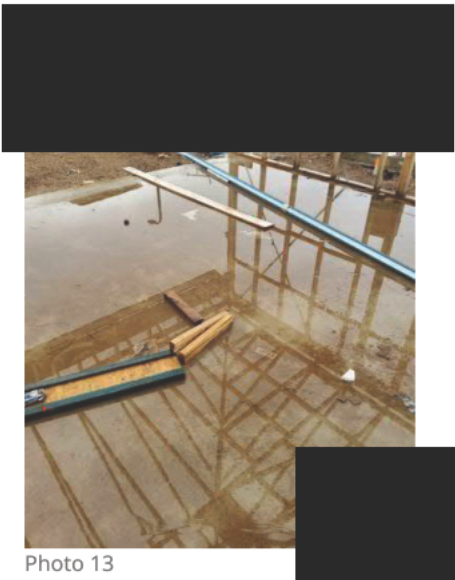
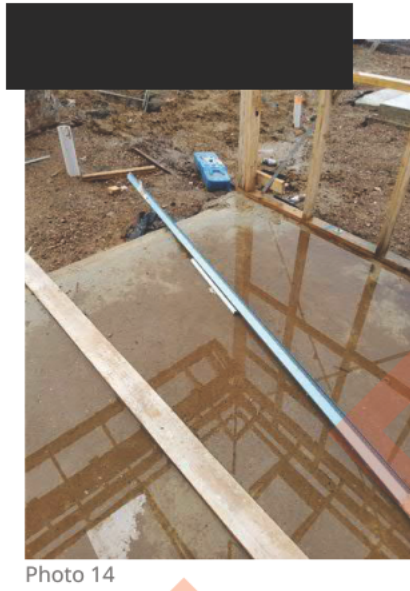
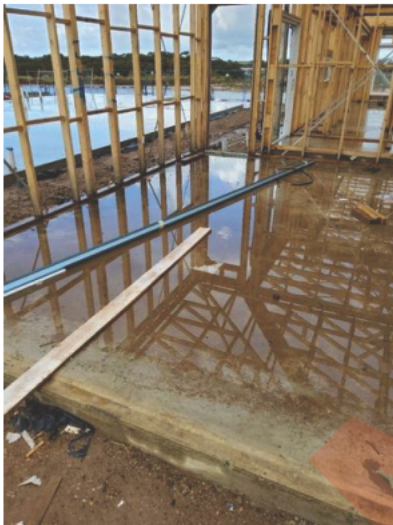
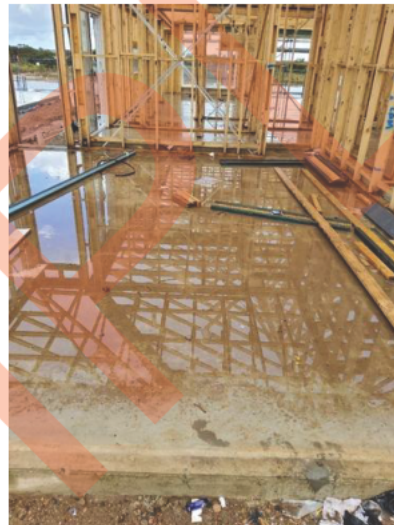
From the levels taken the overall slab exceeds in height, lowest point identified was -15mm and highest identified was +13mm. This equates to 28mm overall to the building which exceeds the tolerance.

Numerous bedrooms also exceed the maximum tolerance of 10mm out of level. These include but are not limited to;

1. Bedroom 27mm (-14mm to +13mm)
2. Ensuite 14mm (+12mm to -2mm)
3. Laundry 13mm (-13mm to 0mm)
4. Family 17mm (-15mm to +2mm)
5. Dining 17mm (-14mm to +3mm)
6. Bed 11mm (-8mm to +3mm)
7. Bed 3. 13mm (-9mm to +4mm)
8. Garage 13mm (-4mm to +9mm)

These areas are also more evident with rain which outlines a number of low/high spots.

A level survey was completed on site with heights taken at approximate 2m x 2m squares. It has been identified during this survey that there are issues with the levelness of the finished floor level that does not comply with the Victorian Building Authorities Guide to Standards and Tolerances section 2.08 Levelness of concrete floors:

Builder to complete their own complete survey and propose with client on how surfaces and levels will be made good, what processes will be involved, what products will be used and get confirmation from RBS that these products and processes are adequate.

The builder should complete their own survey to establish the area's that don't comply with the above tolerance to establish the best method of rectification.

If the builder proposes grinding or using a self-levelling product a scope of works and details are to be provided to the owner prior rectification.

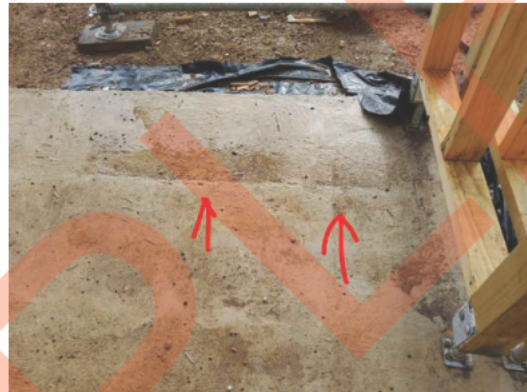
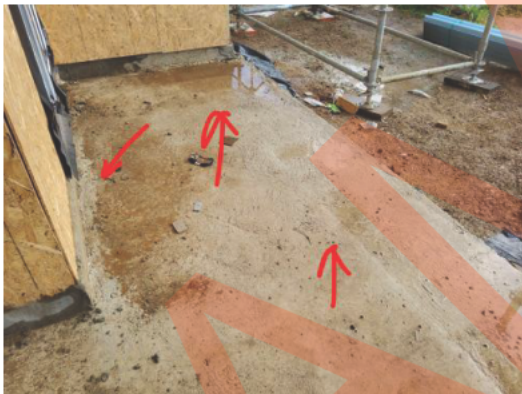
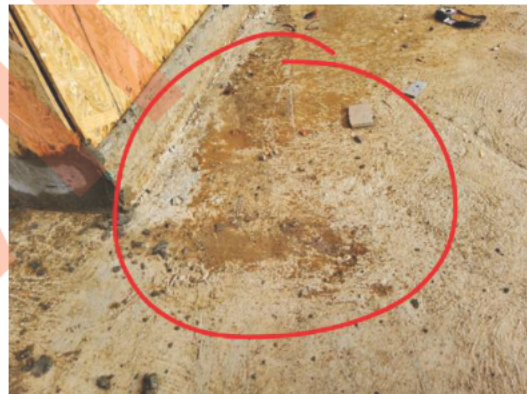
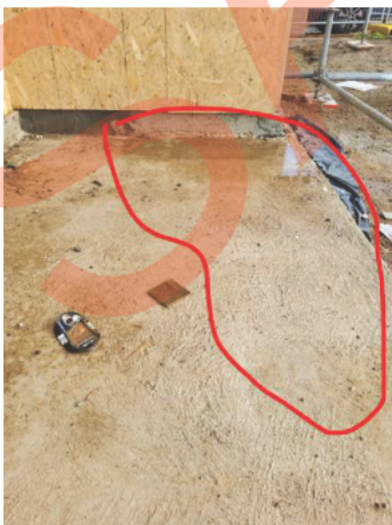
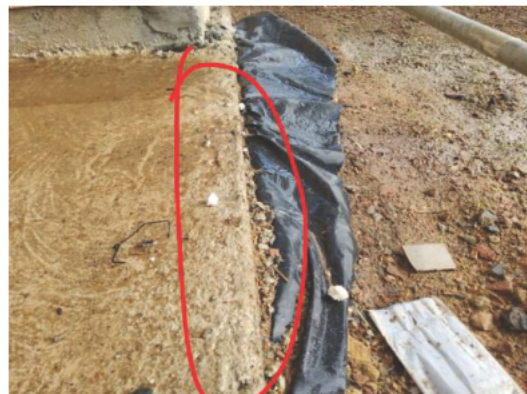
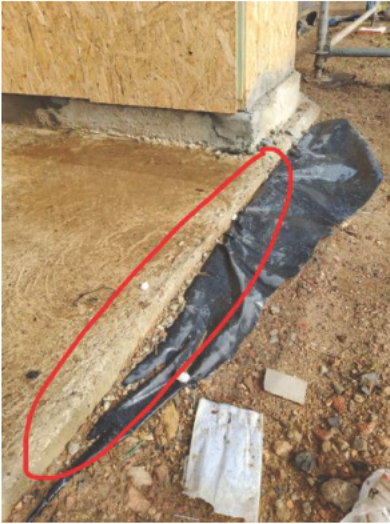
SIGNIFICANT DEFECT

Refer to the Victorian Building Authorities Guide to Standards and Tolerances in particular section 2.11 Finish to concrete slab:  
 "The finish to a concrete slab is defective if it is not suitable for the documented applied finishes such as tiles, polished concrete, carpet or sheet flooring, including set downs where required."

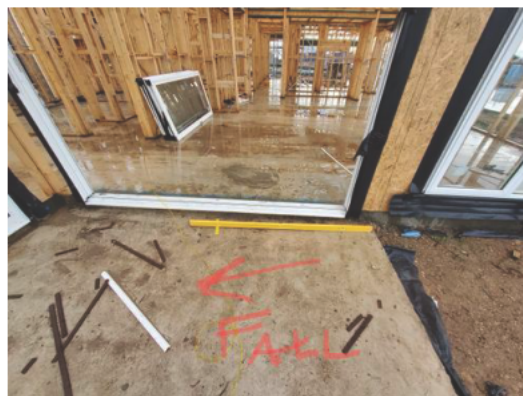
Bow in concrete and falls opposite direction. Refer to the VBA's Guide to Standards and Tolerances section 2.08 Levelness of concrete floors:

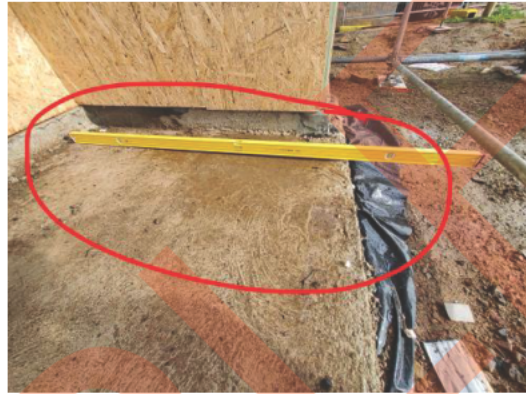
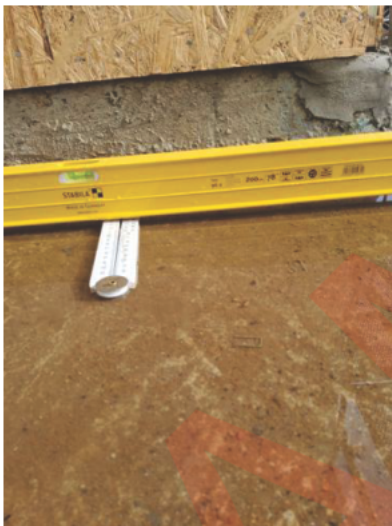
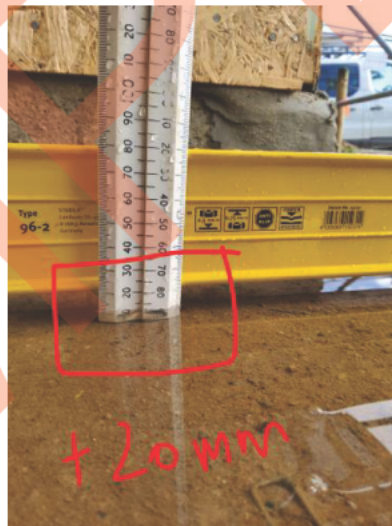
Bow in concrete, up to 20mm visible and water ponding.

Refer to the VBA's Guide to Standards and Tolerances section 2.08 Levelness of concrete floors: "Except where documented otherwise, new floors are defective if within the first 24 months of handover they differ in level by more than 10 mm in any room or area, or more than 4 mm in any 2 m length. The overall deviation of floor level to the entire building footprint shall not exceed 20 mm. Refer to Item I of this Guide where the new floor is to abut an existing floor."

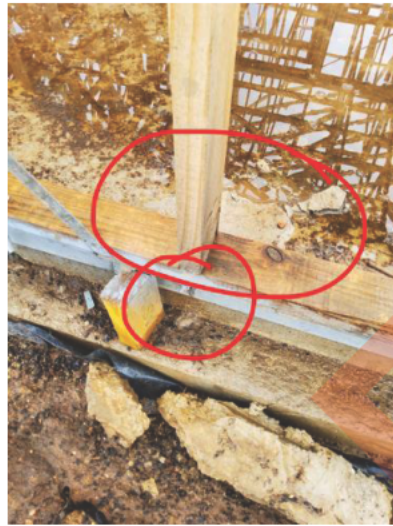
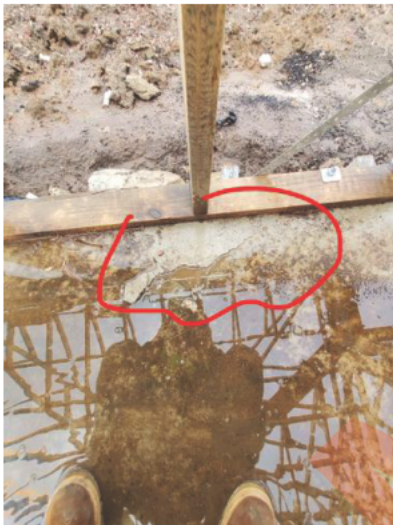
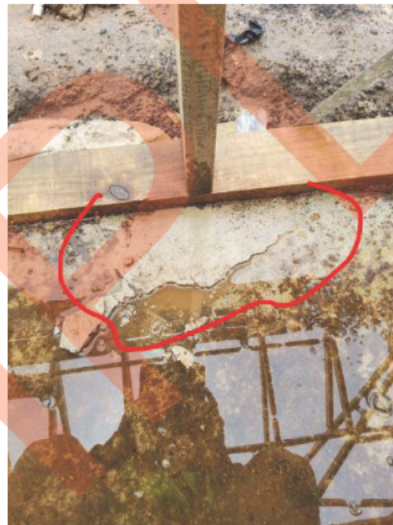
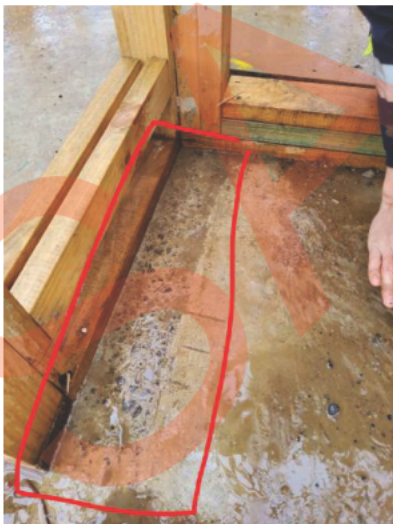
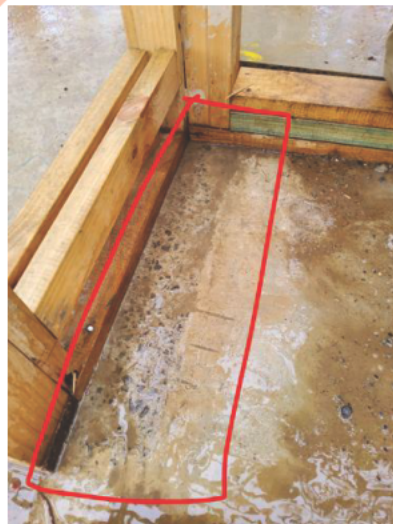
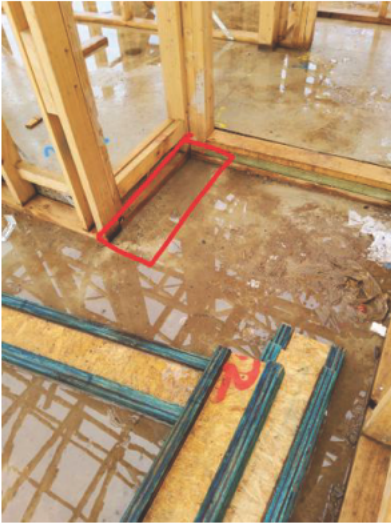
Concrete in garage floor appears to be popped and damaged from rectification works. Also has been cut/ground near internal door.

Poor finish and Engineer and RBS to review and supply a rectification detail
