02 Independent Quality Assurance: Frame Inspection

[REDACTED]

[REDACTED], Australia
[REDACTED]
[REDACTED]

[REDACTED] 2023

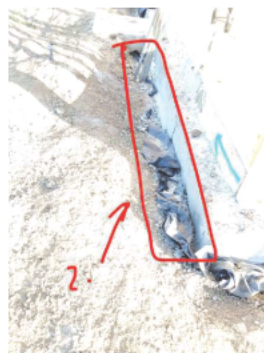
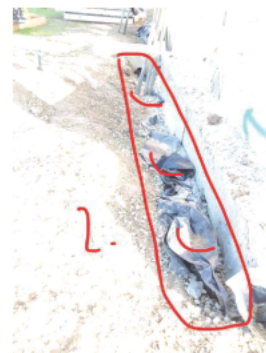
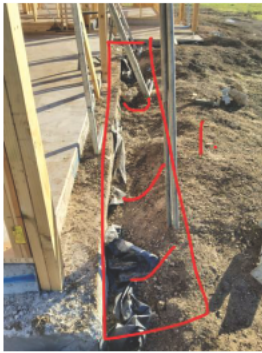
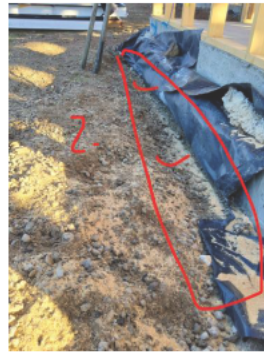
The highlighted locations do not fall away from the footing, a trench has been formed where water can be trapped and pond.

Surface drainage is to be maintained throughout the construction of the house. This is to prevent moisture differences in the soil around the perimeter which could result in movement of footings and foundations. Refer to the specific Engineers drawings/notes and the Soil report. Additionally refer to AS 2870-Residential slabs and footings, part 5.6.3 which outlines specific requirements for class M, H1, H2 and E sites

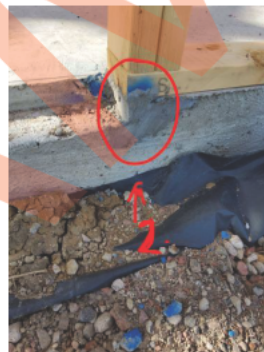
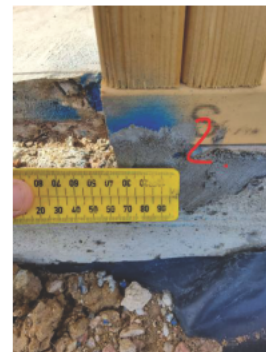
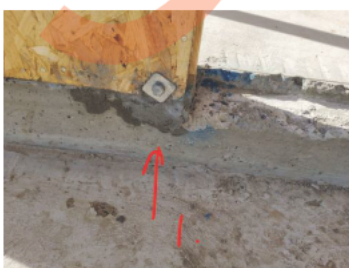
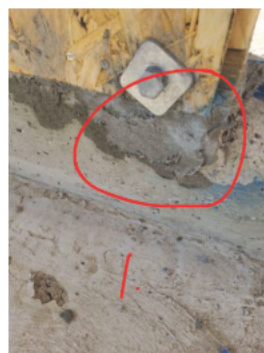
The highlighted recessed slab section have been grouted over and overhang appears to be greater than 20mm, engineer to review

As per the VBA's Guide to Standards and Tolerances section 4.08: "Bottom plates that are 90 mm wide or greater and overhang concrete slabs by more than 10 mm are defective."

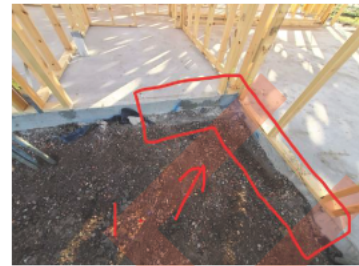
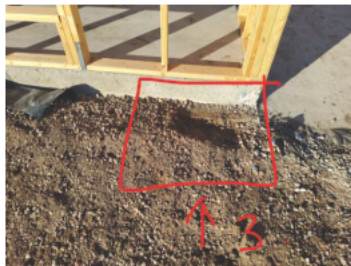
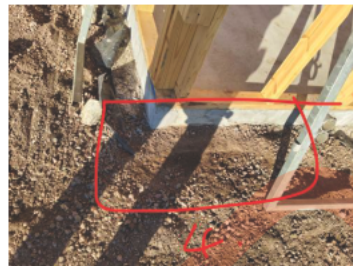
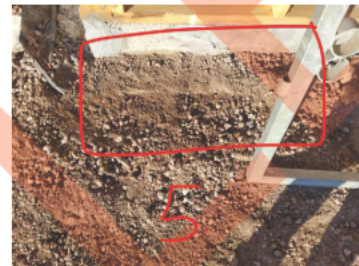
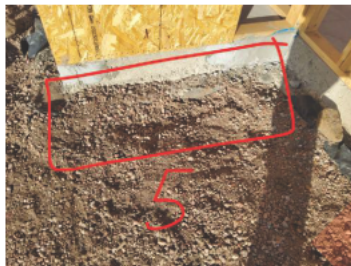
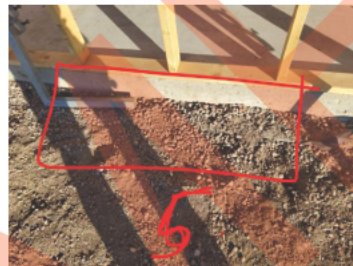
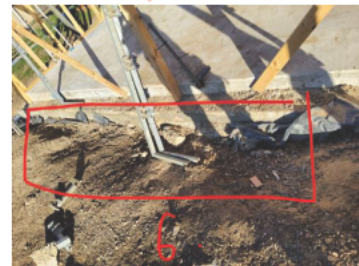
As per the pre pour inspection report some areas still do not have the vapour barrier terminating as per the National Construction Code.

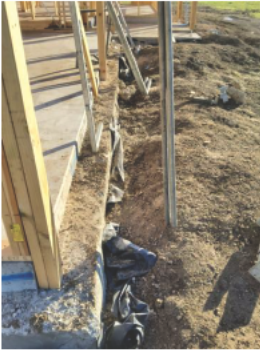
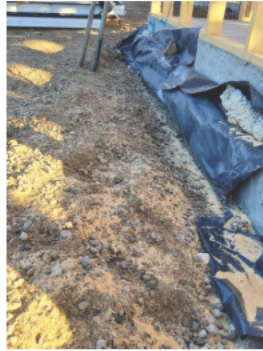
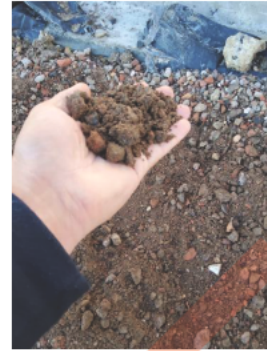
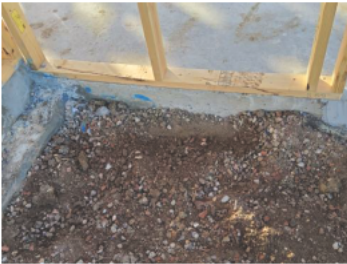
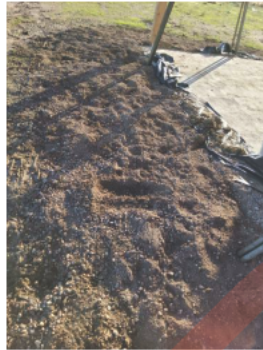
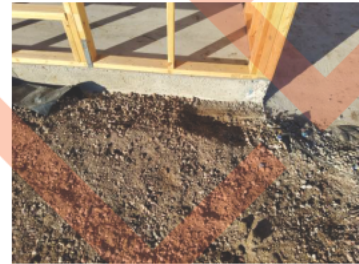
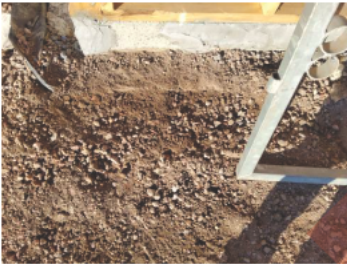
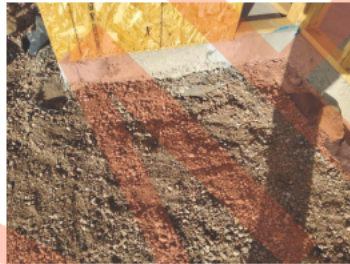
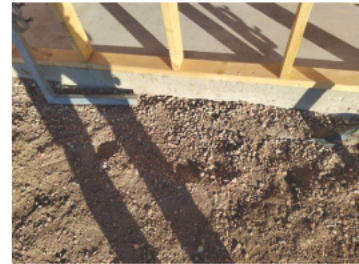
Loose Refer installed to perimeter of dwelling.

AS 2870 Residential slabs and footings section 5.2 DRAINAGE DESIGN REQUIREMENTS, 5.2.1

"Surface drainage shall be designed and constructed to avoid water ponding against or near the footing. The ground in the immediate vicinity of the perimeter footing, including the ground uphill from the slab on cut-and-fill sites, shall be graded to fall 50 mm minimum away from the footing over a distance of 1 m and shaped to prevent ponding of water. Where filling is placed adjacent to the building, the filling shall be compacted and graded to ensure drainage of water away from the building."

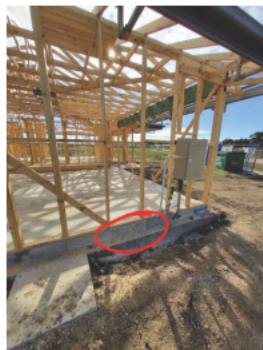
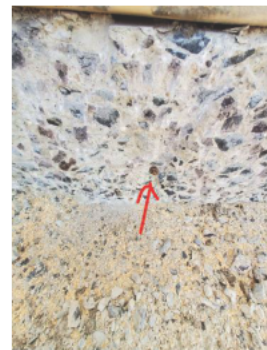
The garage boundary slab face has partially been cutback and there is exposed steel reinforcement.

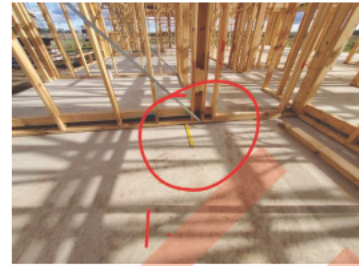
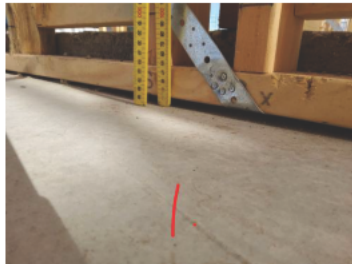
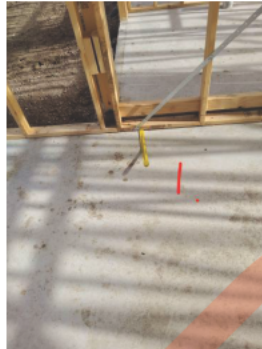
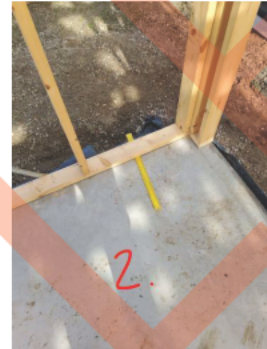
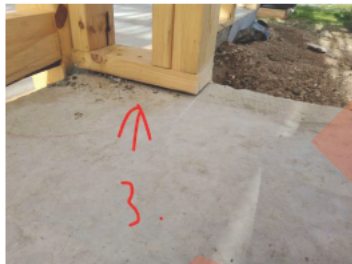
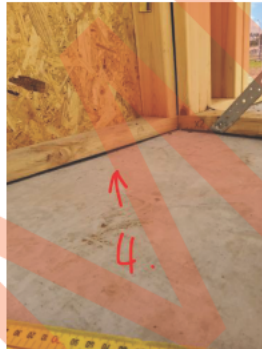
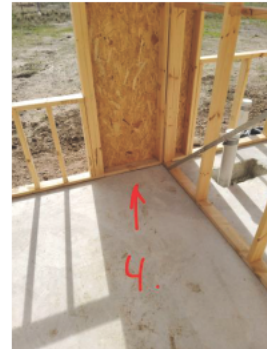
Som areas where the slab dips abs the bottom plate is gapped have not been rectified, these are consistent with the post pour report.

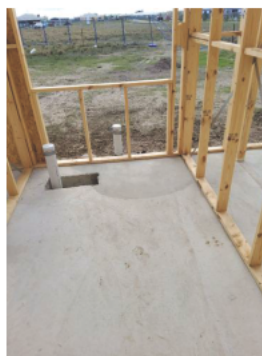
It appears that a product has been used to level the floor in the bathroom/Bed 3.

Please provide product information for review.

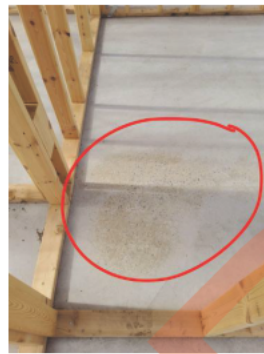
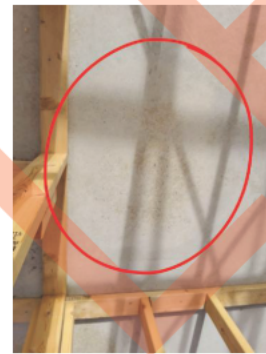
The slab has been ground due to high spot, engineer to review and certify.

"Reinforcement and void formers shall be fixed in position prior to concreting by means of proprietary spacers, bar chairs with bases, ligatures or other appropriate fixings so as to achieve the required reinforcement position and concrete covers. Reinforcement shall not be placed or located after concreting."

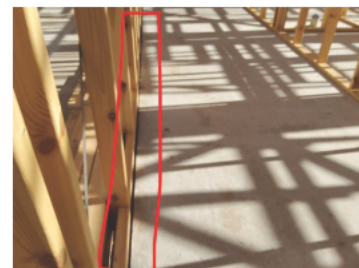
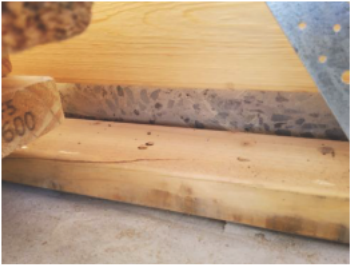
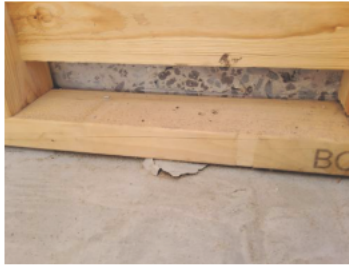
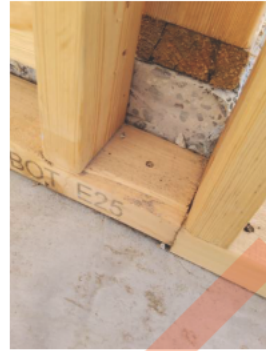
The garage/entry hall way slab has been cut back, works not as per engineers site instruction.

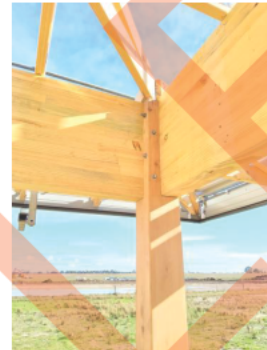
Additional bolts required to rear alfresco beam as per engineers detail due to depth of beam at 470mm.

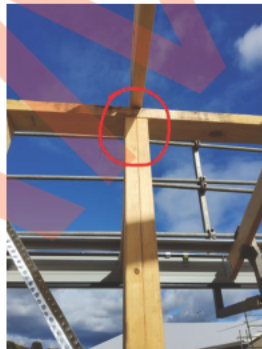
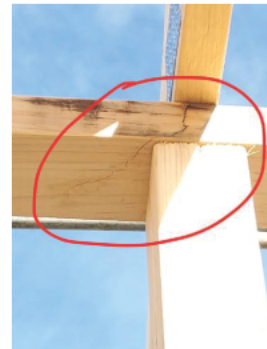
Top plate damaged at girder truss load point.

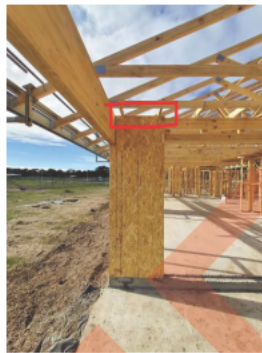
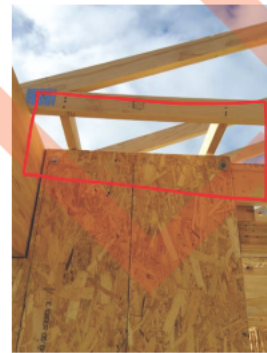
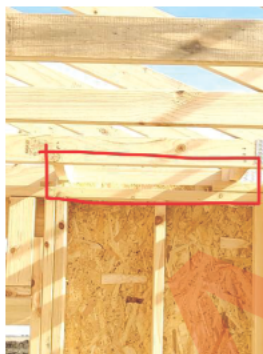
The highlighted living/outdoor living sheet brace/wall has not been provided with the required clearance to the plaster trimmers, this wall is a non load bearing wall.

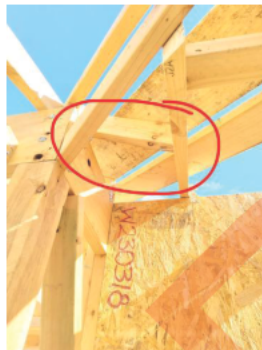
Strut block not installed as per manufacturers specifications.

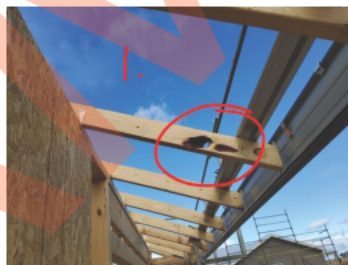
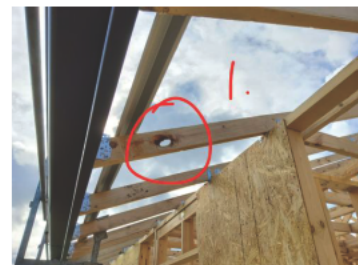
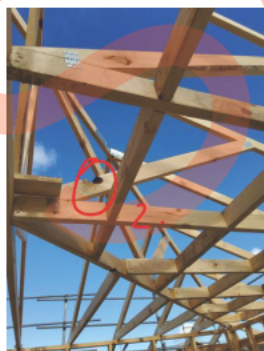
Large knots to truss chord and Web, manufacturers to review and certify.

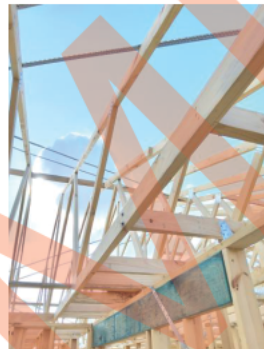
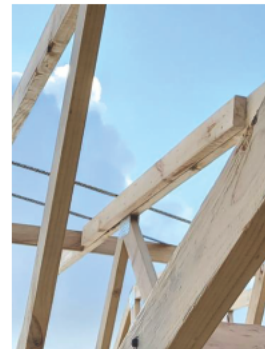
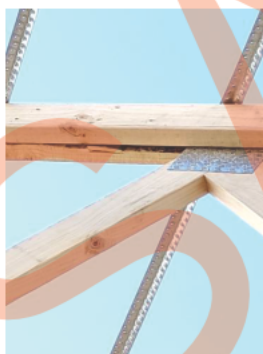
Truss damaged.

NOTE: Design criteria for trusses should be checked when they are delivered to site to ensure that they are the correct trusses. If any truss has been cut, drilled, damaged, or manufactured in such a way as to impair performance, notification should be given to the truss engineer in order to provide adequate rectification to the truss. Trusses with severely degraded timbers or nailplates due to poor storage shall not be loaded prior to rectification or replacement.

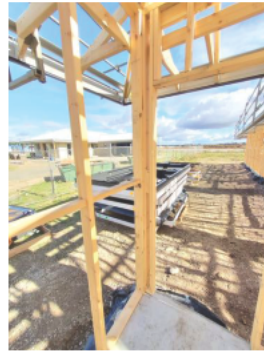
5.1.2: External/internal/load bearing corners shot together

As per AS 1684.4-2010 section 6.2.1.3: "Studs at wall junctions and intersections shall be in accordance with one of the details shown in Figure 6.2. Studs shall be not less in size than common studs. All junctions shall have sufficient studs, which shall be located so as to allow for adequate fixing of linings. Internal and external walls shall be fixed together with a minimum of 2/75 mm nails at 900 mm centres."

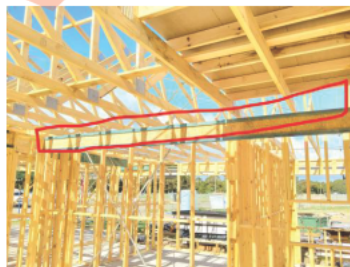
The highlighted area is missing L brackets.

As per AS 4440-2004 section 2.2.3: Non bracing wall for an internal non load bearing wall requires stabilising maximum 1800 mm centres and as per Figure 2.3

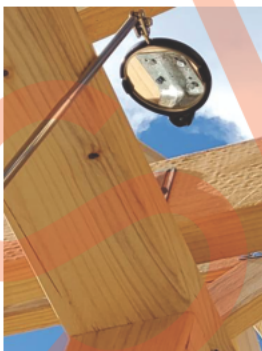
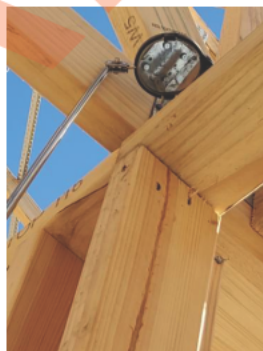
The nails used for the Lbrackets into the top plates are not the proprietary mitek nails and not as per manufacturers specifications
