## 03 Independent Quality Assurance: Pre-plaster Inspection

[REDACTED]

[REDACTED] VIC  
[REDACTED]  
[REDACTED]

Double storey  
Slab on ground  
Timber frame  
Sheet roof  
Brick Veneer  
Rendered lightweight cladding

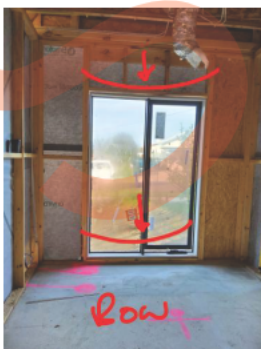
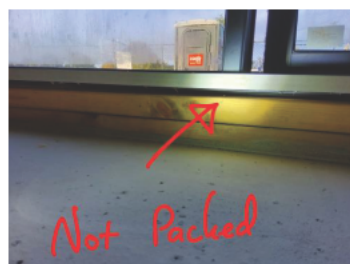
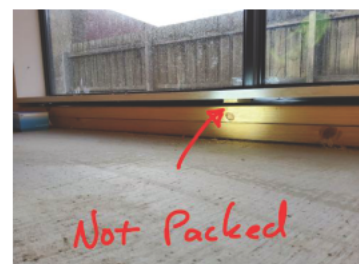
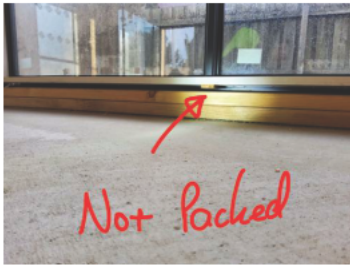
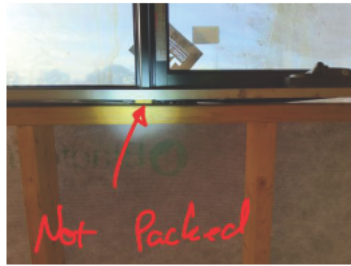
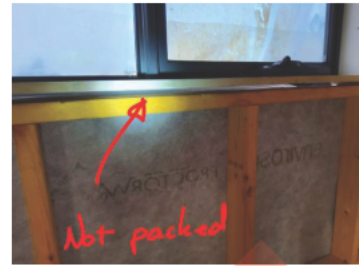
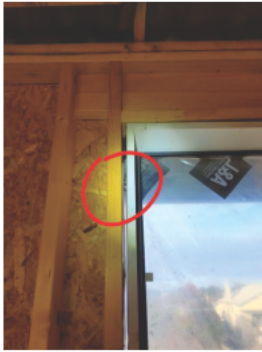
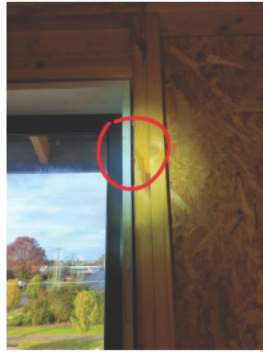
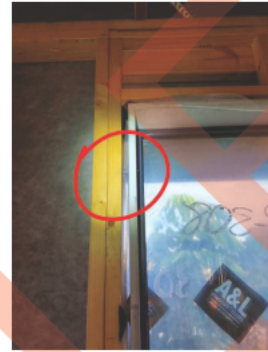
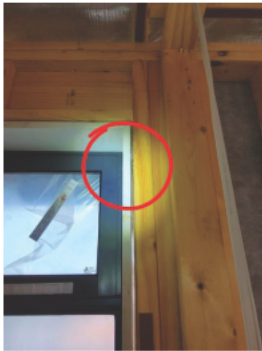
DEFECT

1. Windows not packed under structural members.
2. Windows not packed at fixing locations.

Timber framing standards require minimum 15mm gap at head for settlement, we recommend 20mm, not packed. Other frame types may require less, but we recommend a minimum of 10mm in all cases.

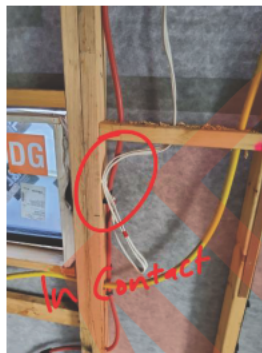
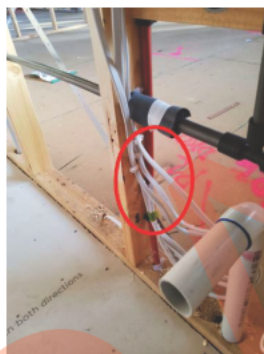
DEFECT

Electrical cables in contact with plumbing services.

Refer to AS 3000 Electrical installations section 3.9.8.4 Proximity to non-electrical services: "(b) Gas and water services Requirements for the separation of distributed gas and water systems from low voltage wiring systems are provided in the AS/NZS 5601 series for gas services and the AS/NZS 3500 series for water services.

Wiring systems shall maintain a separation of not less than 25 mm from any above-ground gas or water piping. Separation from underground gas and water services shall be in accordance with Clause 3.11.5."

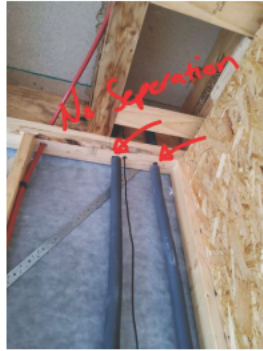
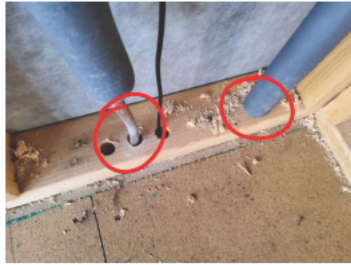
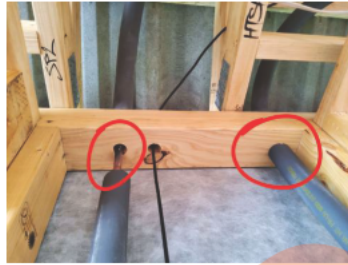
DEFECT

Hot water pipework not sealed around frame penetrations.

Refer to AS 3500.4 Heated water services section 4.5 LOCATION OF PIPING, 4.5.1 Concealed piping, 4.5.1.1 Walls:

(ii) Where unlagged pipes are used, a collar of lagging material or a neutral cure silicone sealant shall be used to fill the annular space."

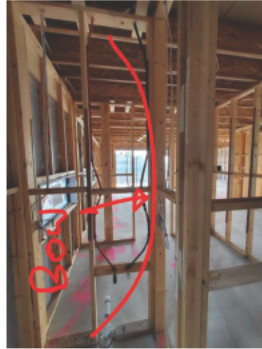
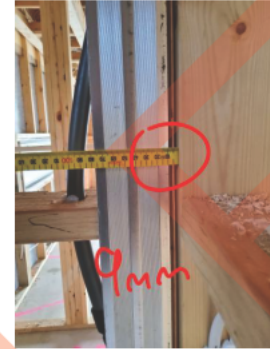
#### 3.1.2: Corner/door/window/opening studs straight?

DEFECT

As per Australian Standard 2589: Gypsum linings—Application and finishing, section 4.2.2 Finished framing deviations and tolerances:  
“The deviation in the position of the bearing surface of the finished framing immediately prior to installation of lining from a 1.8 m straight edge shall not exceed the values given in Table 4.2.2 when measured over a 1.8 m span at any point [see Figure 4.2.2(A)].”

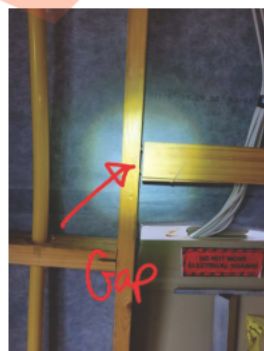
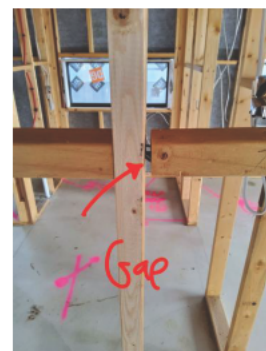
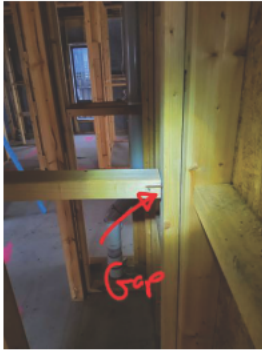
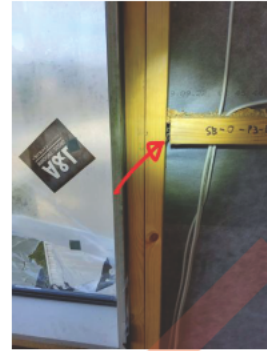
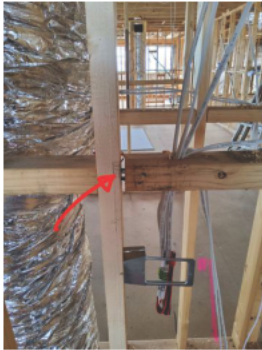
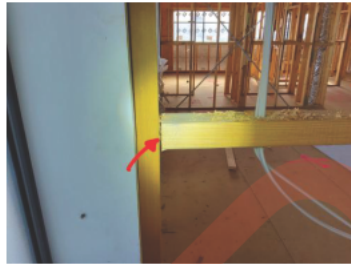
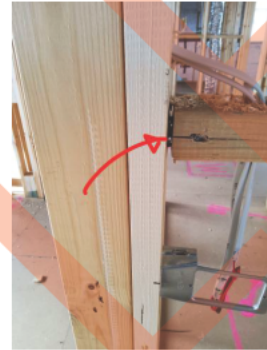
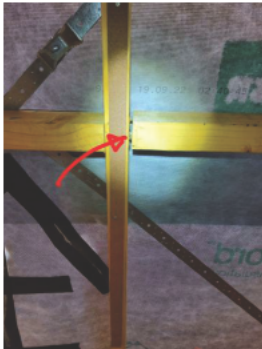
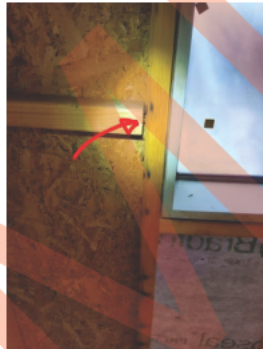
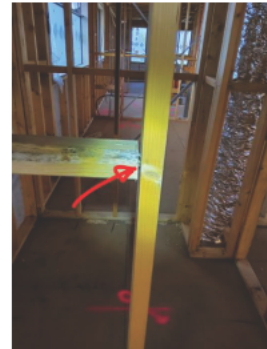
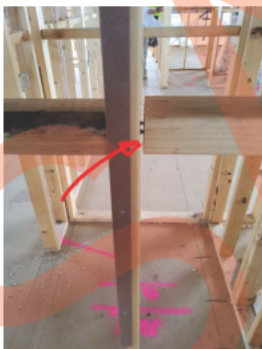
**3.1.4: Noggings (typical) installed and continuous**

**DEFECT**

Noggings are required to be installed so they are continuous as per AS 1684.4 section 6.2.1.5: "Where required, wall studs shall have continuous rows of noggings, located on flat or on edge, at 1350 mm maximum centres (see Figure 6.5)."

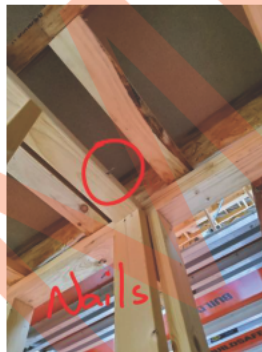
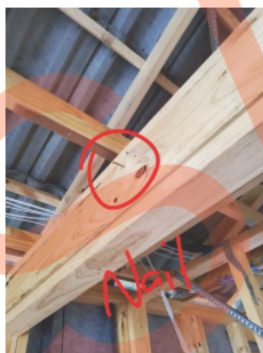
**DEFECT**

Nails proud of wall.

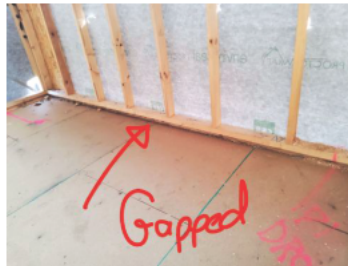
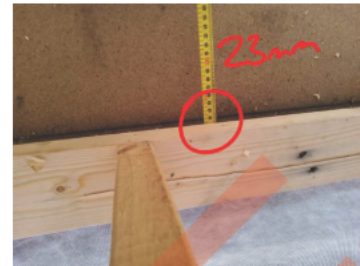
**DEFECT**

No fixing for skirting.

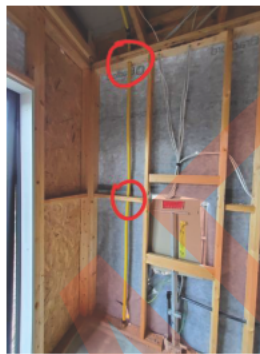
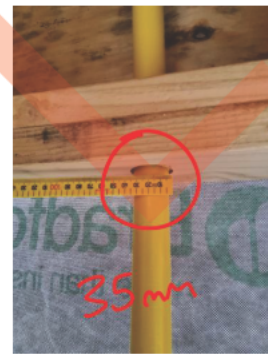
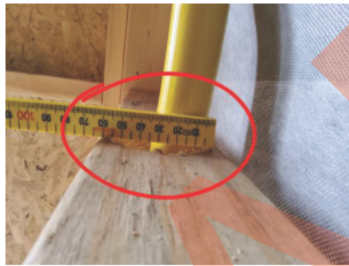
#### +3.3.2: Size of holes in top plate

SIGNIFICANT DEFECT

Maximum hole permissible in the top plate is as per AS 1684.4 - Residential timber framed construction, section 6.2.1.4, Figure 6.3 and Table 6. Maximum hole diameter of 25mm centralised to the plate

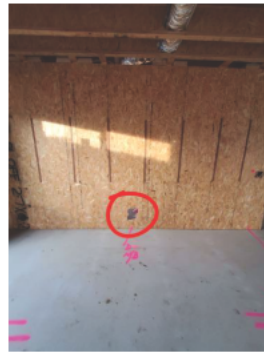
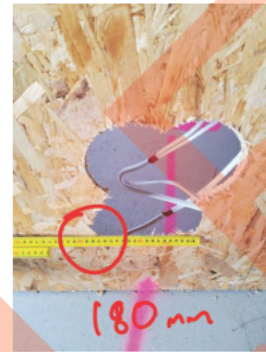
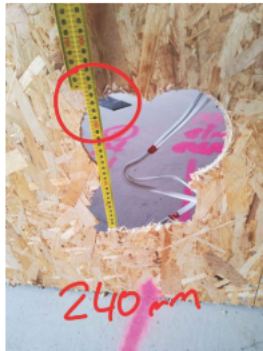
SIGNIFICANT DEFECT

Hole in bracing panel exceeds maximum tolerance as per OS'Brace installation guide:

A hole 100 × 100 mm maximum within an envelope of 100 mm from top and vertical edges and 200 mm of the bottom of the bracing panel will not significantly affect the bracing capacity. Multiple holes of this size are permitted provided the centre lines of the holes are not closer than 600 mm."

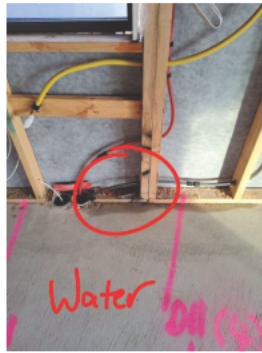
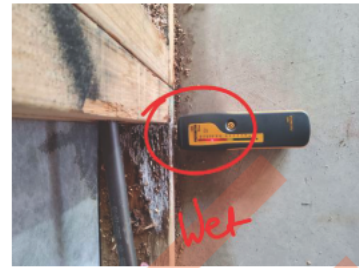
SIGNIFICANT DEFECT

Visibly wet timber was identified in the kitchen under structural framing members reading 40% moisture content.

"Where the moisture content is less than 20%, and remains so, decay will not occur (or continue if it has started) although surface mould and stain may be present. An moisture content 20% or above is conducive to decay and needs to be addressed."

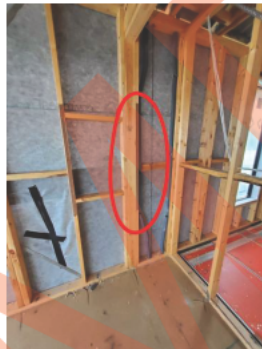
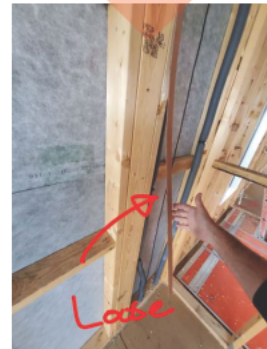
**DEFECT**

Packer not adequately fixed to stud and is not suitable for plasterboard installation with adhesive.

Refer to AS 2589 - Gypsum linings—Application and finishing section 2.5 FRAMING SUBSTRATES: "Gypsum linings require a stable substrate at the time of installation in order to minimize in-service surface defects."

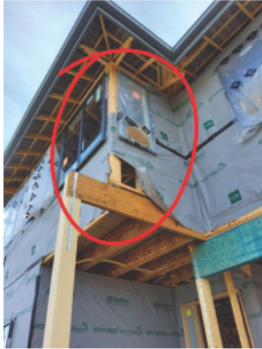
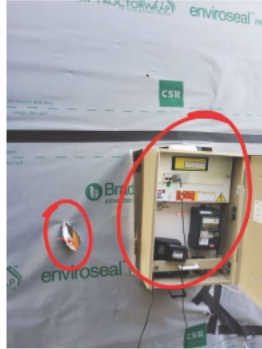
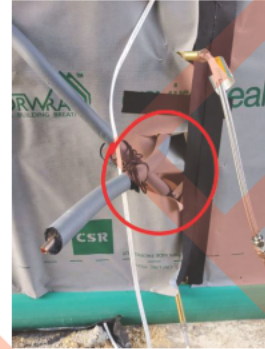
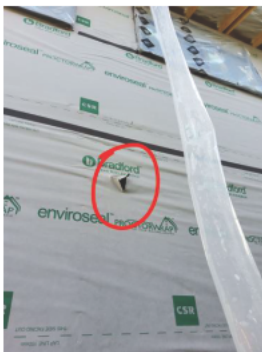
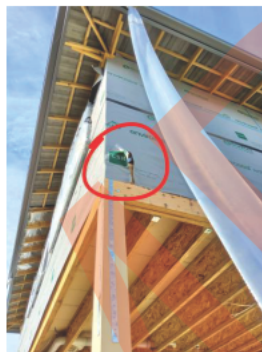
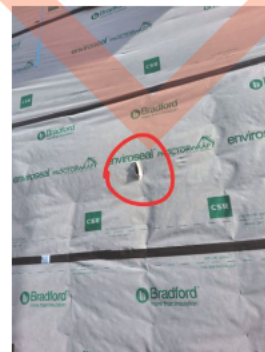
### 4.3.2: Sisalation penetrations

DEFECT

Refer to Australian Standards AS 4200.2, Pliable building membranes and underlays sections 4.3 VAPOUR CONTROL AND AIR CONTROL and 4.4 WATER CONTROL respectively:

"Where a pliable building membrane is installed as a water control membrane, penetrations shall be sealed with a pressure-sensitive and heat- and moisture-resistant tape.

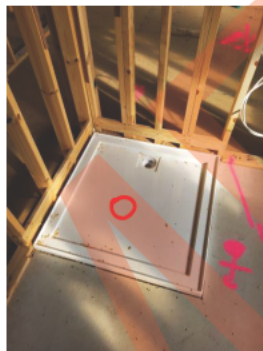
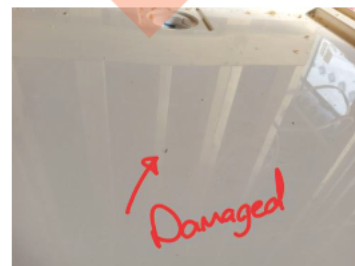
DEFECT

Shower base chipped / damaged.

Refer to the VBA's Guide to Standards and Tolerances section 10.06 Manufactured material: "Any cracking, displacement, pitting or similar blemishes in surfaces of manufactured materials are defective if they are caused by the builder and can be seen from a normal viewing position."

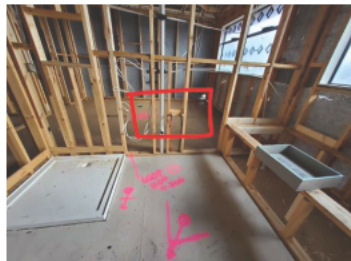
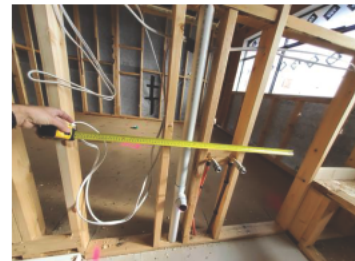
DEFECT

No noggins to adequately fix corners of cabinetry to wall.

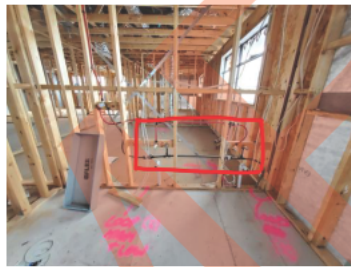
DEFECT

No noggins to adequately fix corners of cabinetry to wall.

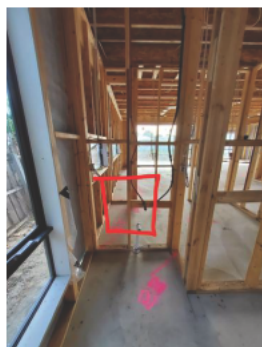
DEFECT

No noggins to adequately fix corners of cabinetry to wall.

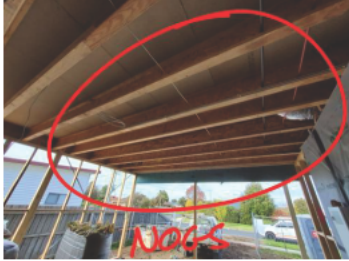
Photo 76

DEFECT

No garage door noggins installed.
