04 Independent Quality Assurance: Waterproof/Fix Inspection

04 Independent Quality Assurance: Waterproof/fix Inspection /

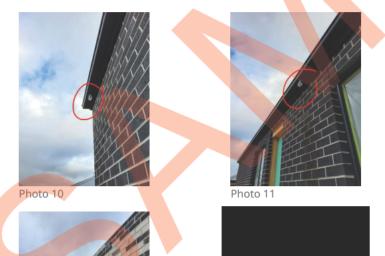
Temporary downpipes not connected throughout.

As per ENG S18:

-ALL WATER RUN-OFF SHALL BE CONTROLLED AT ALL TIMES - USE TEMPORARY DOWNPIPES TO COLLECT WATER FROM THE ROOFED BUILDING FRAME;

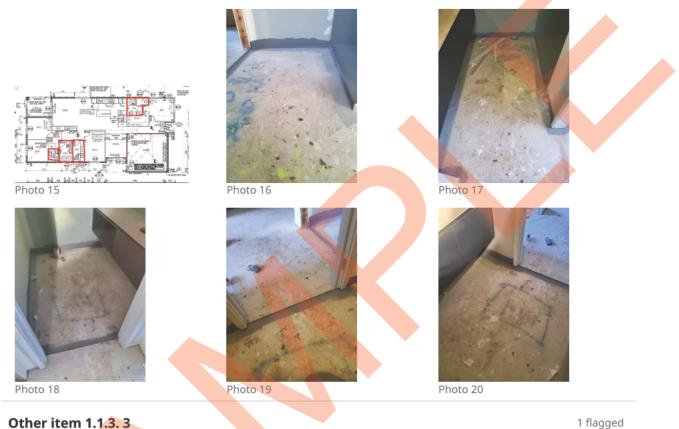
Membrane not protected:

Membrane not protected. Refer to AS 3740: Waterproofing of domestic wet areas; section 3.5 CURING OF MATERIALS:

NOTE: The membrane should be protected from physical and/or chemical damage until covered by the finished surfaces.

Wall positioning not as per WD A03. Bulkhead finishes above doorway, not as per Drawings.

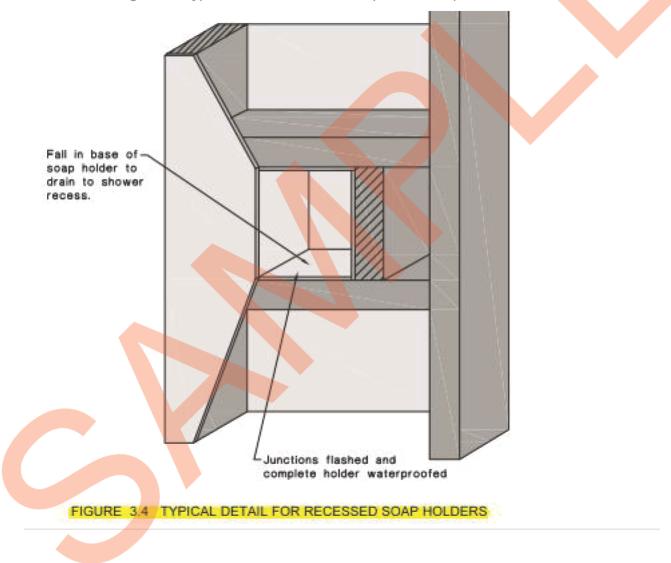
Fall in shower niche in opposite direction.

AS 3740-2010 Figure 3.4 Typical detail for recessed soap holders requires fall to the base

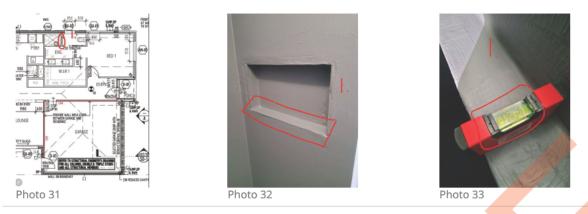
No fall to base.

AS 3740-2010 Figure 3.4 Typical detail for recessed soap holders requires fall to the base

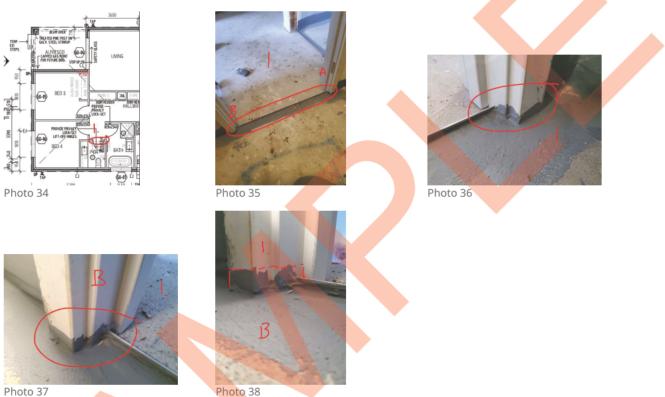
Waterstop not continuous & door architrave flush with the floor.

A waterstop is required to be installed at floor level openings as per AS 3740:2021-Waterproofing of domestic wet areas section 4.9.1: Perimeter flashing at floor level openings: "The following requirements apply to perimeter flashing at floor level openings: ...(b) Waterproofing other than whole wet area floor waterproofing shall incorporate a waterstop

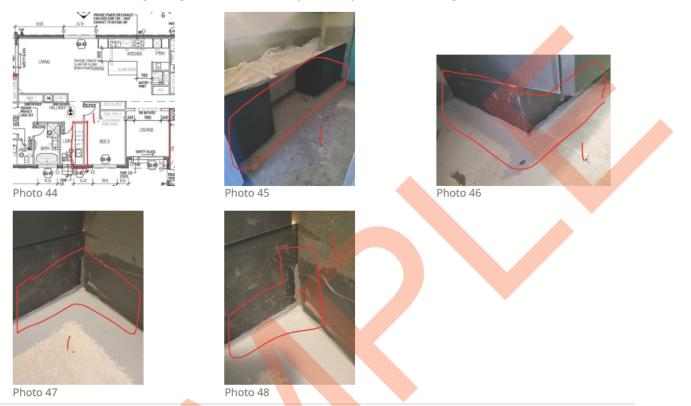
Junctions underneath joinery not sealed/waterproofed prior to cabinetry installation.

The Building Code of Australia Volume Two Part 3.8.1.2 Wet Areas states "Building elements in wet areas within a building must— (a) be waterproof or water resistant in accordance with Table 3.8.1.1 ; and (b) comply with AS 3740." Table 3.8.1.1 requires wall and floor junctions to be "water resistant"

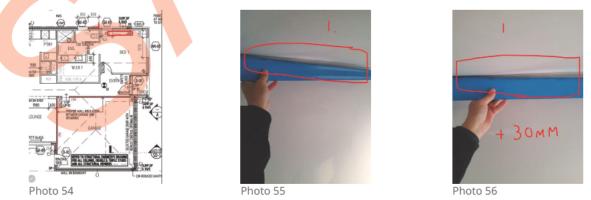
Large 30mm bow in ceiling/cornice. Refer to Pre-plaster Inspection report which shows sump dropping below ceiling line.

As per Australian Standard 2589: Gypsum linings—Application and finishing, section 4.2.2 Finished
