05 Independent Quality Assurance: Final Inspection

Double storey
Slab on ground
Split level
Timber frame
Structural steel
Sheet roof
Lightweight cladding
Rendered lightweight cladding

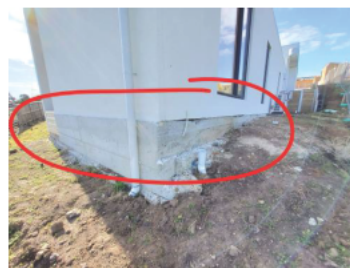
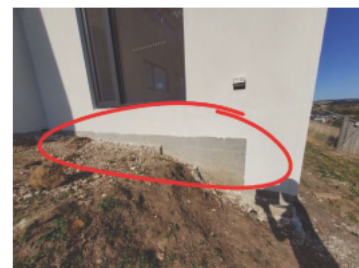
1. Approved plans show concrete edge beams to be rendered as per the external wall finish, on site these have been left as concrete.

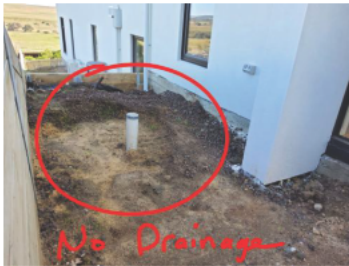
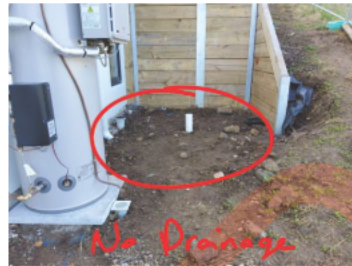
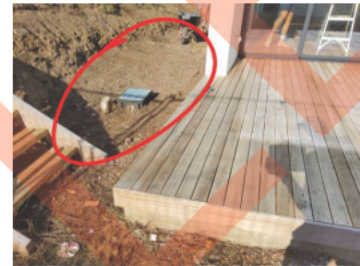
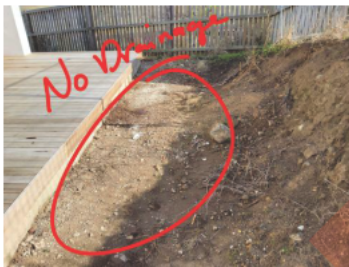
Surface water is not being directed away from footings and collected into surface drainage/ silt pits throughout site.

Site drainage is critical to the maintaining equal moisture levels around the the perimeter of the building. Ponding water or inadequate drainage will result in unequal moisture levels and movement of footings and foundations. Specific attention should be made to the Engineering and soil report requirements along with the National Construction Code/Building Code of Australia Volume 2 section 3.1.3.3 Surface water drainage:

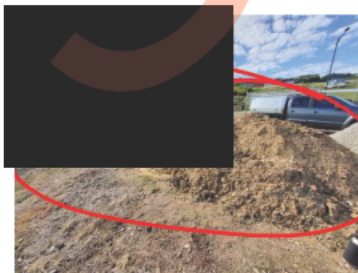
Site not yet cleaned.

As per the VBA's Guide to Standards and Tolerances section 18.08: "Owners are entitled to expect

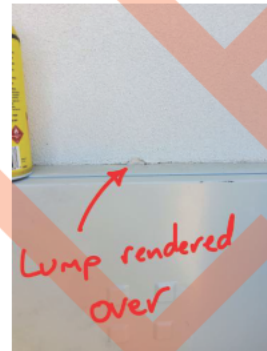
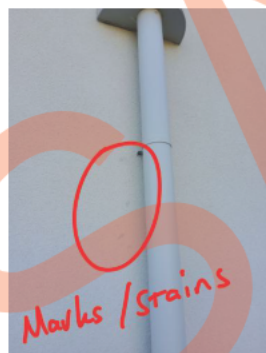
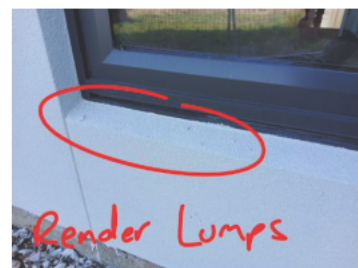
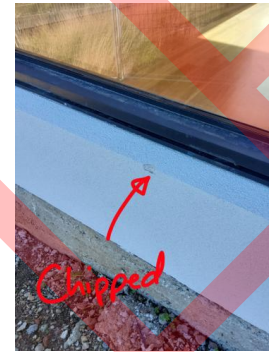
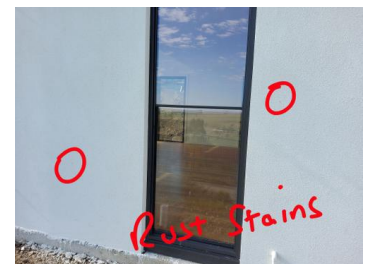
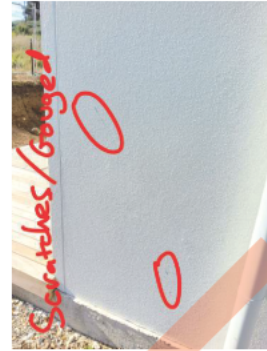
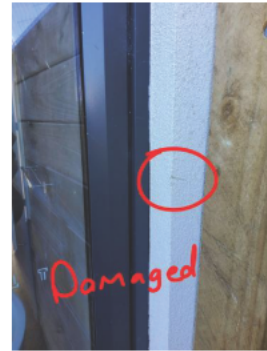
Numerous imperfections visible in render from a normal viewing position as per marked up plans and photos.

As per the VBA's Guide to Standards and Tolerances section 9.04 Cracking and other blemishes in rendered or hard plastered surfaces on a masonry substrate:
 "Obvious spot rust marks, due to the composition of the material and other blemishes are defective if they are visible from a normal viewing position."

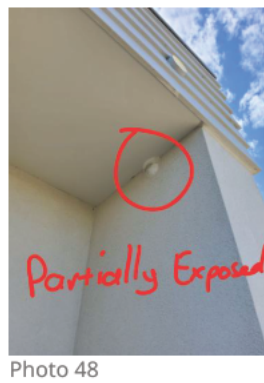
Downpipe has been hidden within the wall space however a section at the top has been left exposed.

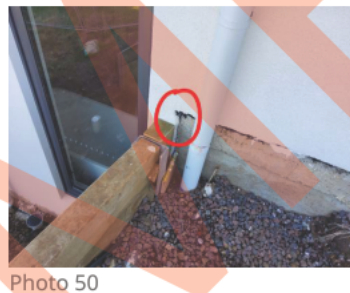
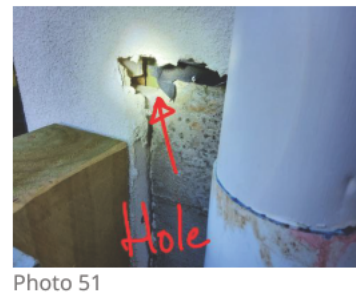
Hole visible through external wall cladding exposing wall framing.

Refer to the National Construction Code, performance requirement P2.2.2 Weatherproofing: "A roof and external wall (including openings around windows and doors) must prevent the penetration of water that could cause— (a) unhealthy or dangerous conditions, or loss of amenity for occupants; and (b) undue dampness or deterioration of building elements."

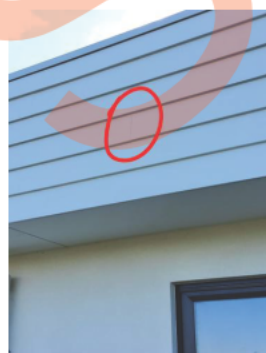
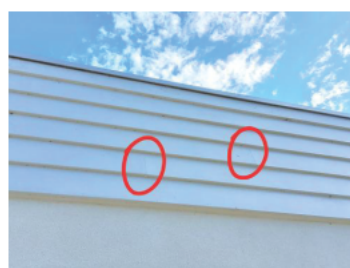
Numerous cladding joints throughout are poorly finished.

As per the VBA's Guide to Standards and Tolerances section 5.02 states:
 "Staining, folds, splits, dents, open joints between panels, cracking and other distortions in wall cladding are defective if they are visible from a normal viewing position at ground level or an upper floor level."

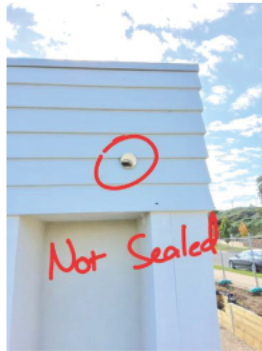
1. Wall penetration not sealed.

The Building Code of Australia Volume 2, Performance Requirement P2.2.2 Weatherproofing:
 "A roof and external wall (including openings around windows and doors) must prevent the penetration of water that could cause—
 (a) unhealthy or dangerous conditions, or loss of amenity for occupants; and
 (b) undue dampness or deterioration of building elements."

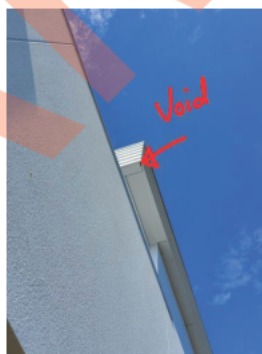
Cladding is short leaving an open void into the roof.

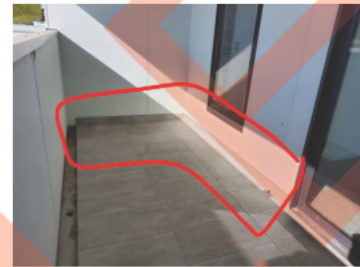
Photo 60

Cladding not clear of decking 50mm, confirm manufacturers warranty remains with this type of installation detail.

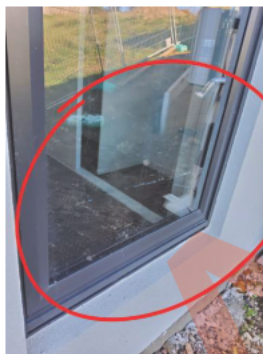
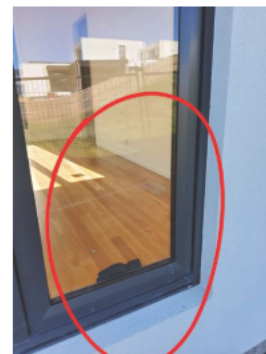
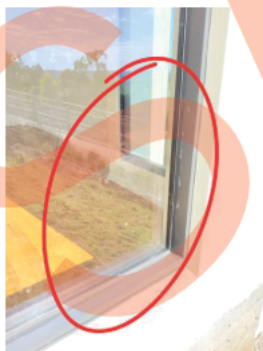
Windows not yet clean and render stains visible throughout.

As per the VBA's Guide to Standards and Tolerances section 18.08 Cleaning: "Building works are defective where windows are not clean". As not clean damage not easily visible.

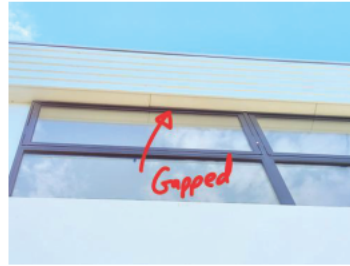
The eave lining is short to the window frame.

The Building Code of Australia Volume 2, Performance Requirement P2.2.2 Weatherproofing: "A roof and external wall (including openings around windows and doors) must prevent the penetration of water that could cause—
 (a) unhealthy or dangerous conditions, or loss of amenity for occupants; and
 (b) undue dampness or deterioration of building elements."

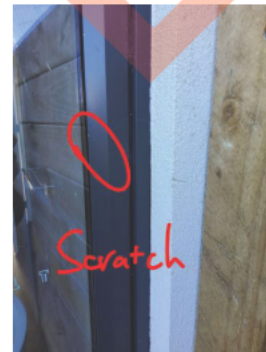
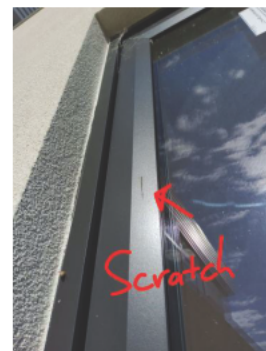
Refer to the VBA's Guide to Standards and Tolerances section 10.06 Manufactured material: "Any cracking, displacement, pitting or similar blemishes in surfaces of manufactured materials are defective if they are caused by the builder and can be seen from a normal viewing position."

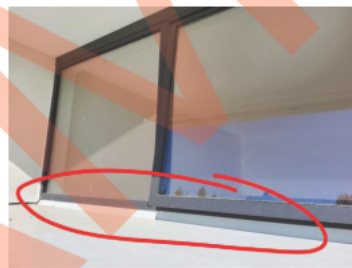
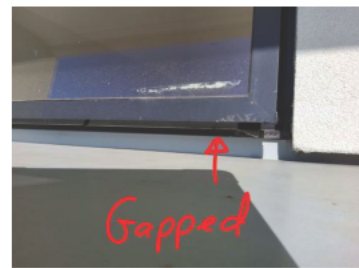
Flashing gapped and not sealed to bottom of window allowing wind driven rain to enter the wall cavity.

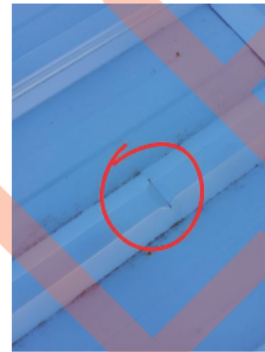
Photo 83

Numerous roof sheets have been creased and split open, these damaged sheets require replacement.

The VBA's Guide to Standards and Tolerance's section 6.02 states "Staining, folds, splits, dents, open joints between panels, cracking and other distortions in roof cladding is defective if it is visible from a normal viewing position at ground level or an upper floor level."

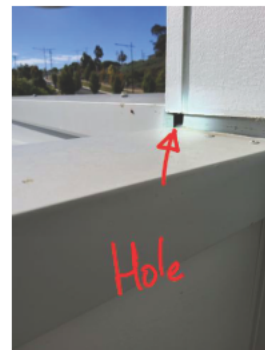
Photo 89

Void visible into wall cavity.

The Building Code of Australia Volume 2, Performance Requirement P2.2.2 Weatherproofing: "A roof and external wall (including openings around windows and doors) must prevent the penetration of water that could cause—
 (a) unhealthy or dangerous conditions, or loss of amenity for occupants; and

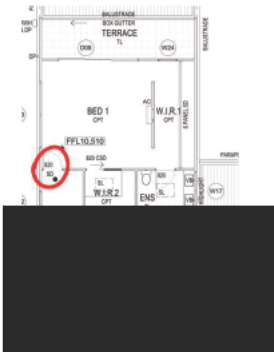
Photo 149

Screws missing from door hinges.

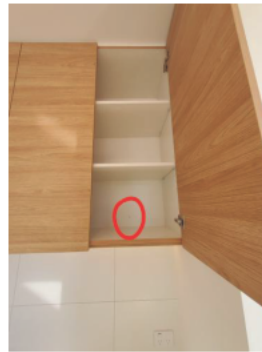
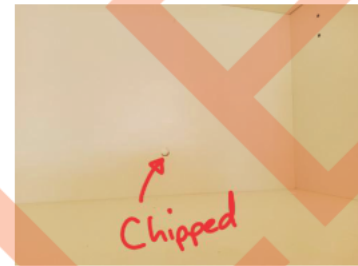
Cabinet chipped around fixing and not covered by cover.

The VBA's Guide to Standards and Tolerance's section 10.06 "Manufactured material" states: "Any cracking, displacement, pitting or similar blemishes in surfaces of manufactured materials are defective if they are caused by the builder and can be seen from a normal viewing position."

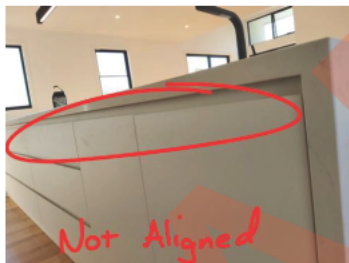
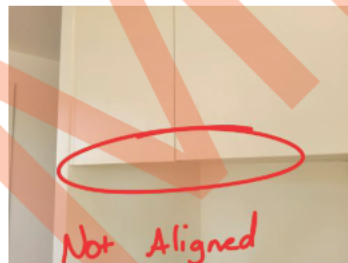
Cabinet doors not aligned throughout.

The VBA's Guide to Standards and Tolerance's section 10.04 states: "Unless otherwise specified, cabinet door and drawer fronts are defective if they are not aligned, or do not have consistent gaps between them at handover, and can be seen from a normal viewing position."
