02 Independent Quality Assurance: Frame Inspection

[REDACTED]

[REDACTED], Australia
[REDACTED]
[REDACTED]

[REDACTED] 2023

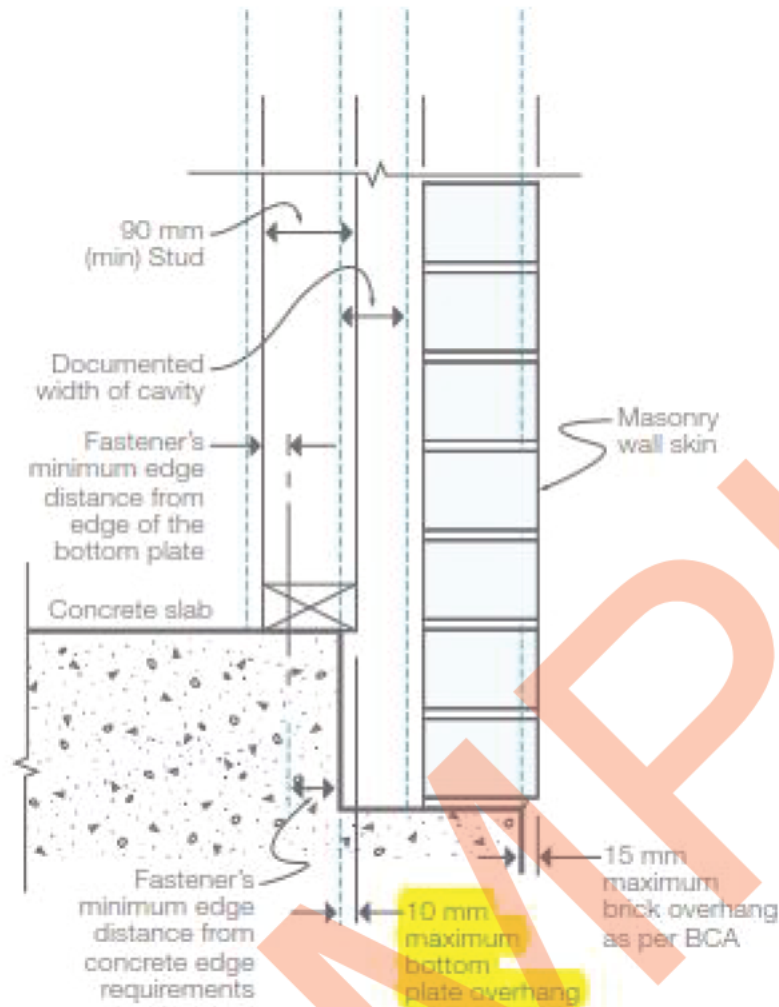
As per the VBA's Guide to Standards and Tolerances section 4.08: "Bottom plates that are 90 mm wide or greater and overhang concrete slabs by more than 10 mm are defective."

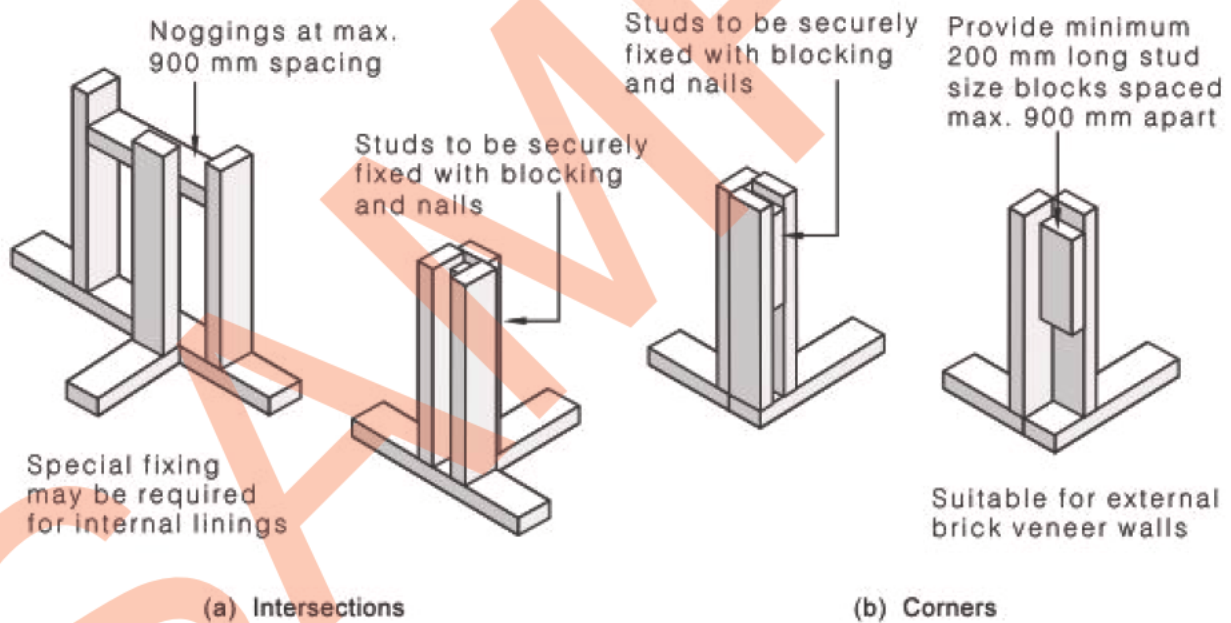
FIGURE 6.2 TYPICAL WALL JUNCTIONS

As per AS 1684.4-2010 section 6.2.1.3: "Studs at wall junctions and intersections shall be in accordance with one of the details shown in Figure 6.2. Studs shall be not less in size than common studs. All junctions shall have sufficient studs, which shall be located so as to allow for adequate fixing of linings. Internal and external walls shall be fixed together with a minimum of 2/75 mm nails at 900 mm centres."

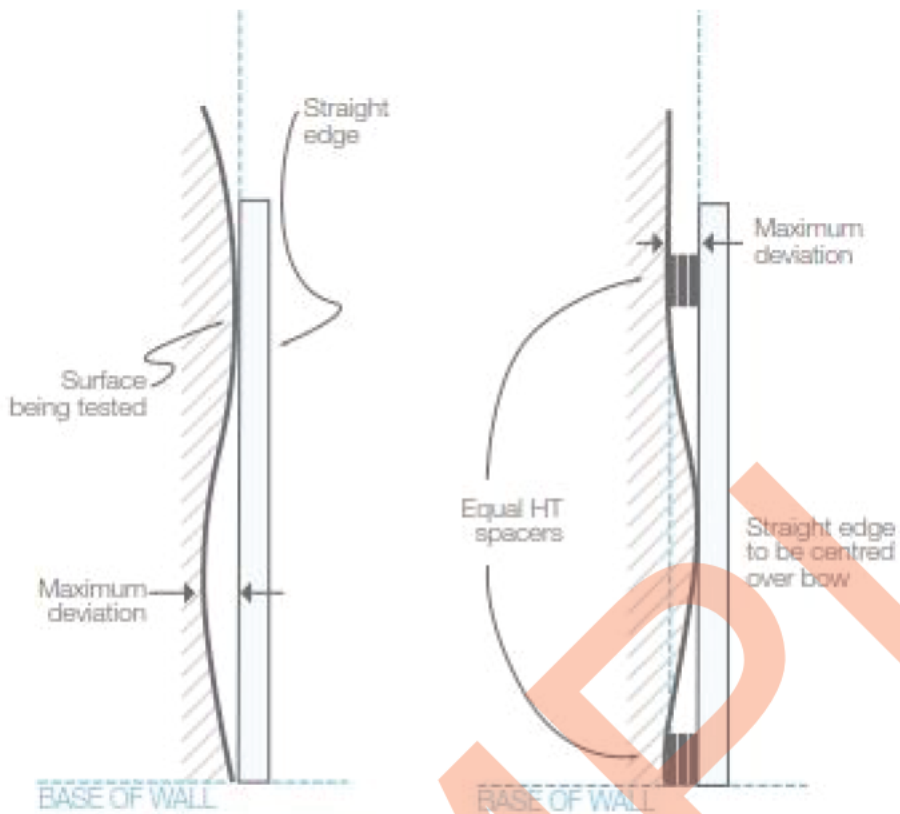
As per the VBA's Guide to Standards and Tolerances section 4.03: "Frames are defective if they deviate from plane (horizontal or vertical bow) by more than 4 mm in any 2 m length of wall."

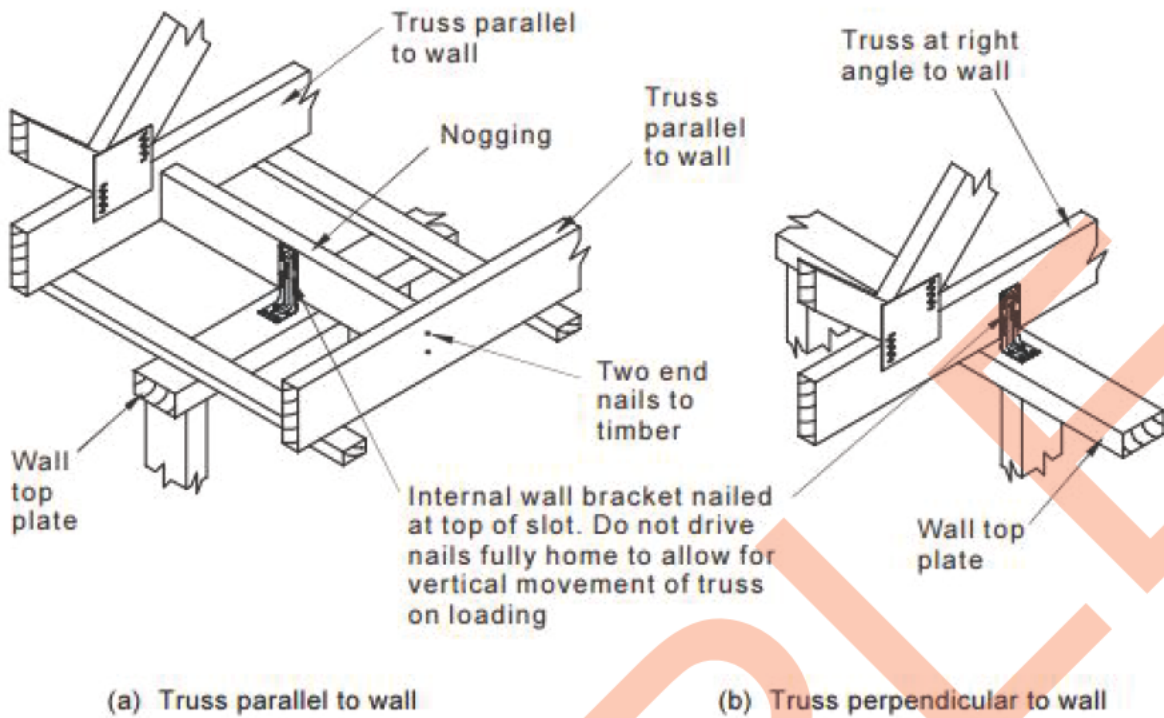
FIGURE 2.3 FIXING OF TRUSSES TO FREESTANDING NON-LOADBEARING WALL THAT IS NOT A BRACING WALL

The highlighted area is missing L brackets.

As per AS 4440-2004 section 2.2.3: Non bracing wall for an internal non load bearing wall requires stabilising maximum 1800 mm centres and as per Figure 2.3
