05 Independent Quality Assurance: Final Inspection

Double storey
Slab on ground
Split level
Timber frame
Structural steel
Sheet roof
Lightweight cladding
Rendered lightweight cladding

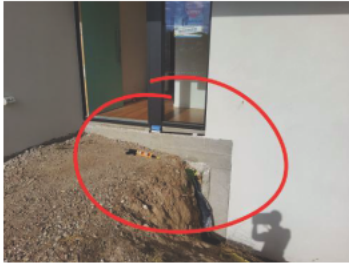
Photo 7

1. Approved plans show concrete edge beams to be rendered as per the external wall finish, on site these have been left as concrete.

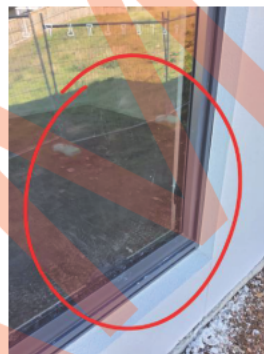
Photo 62

Windows not yet clean and render stains visible throughout.

As per the VBA's Guide to Standards and Tolerances section 18.08 Cleaning: "Building works are defective where windows are not clean". As not clean damage not easily visible.

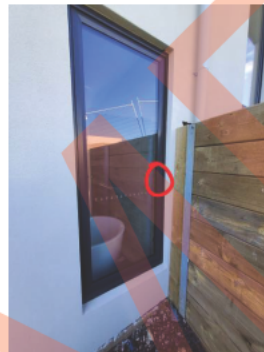
Photo 68

Refer to the VBA's Guide to Standards and Tolerances section 10.06 Manufactured material: "Any cracking, displacement, pitting or similar blemishes in surfaces of manufactured materials are defective if they are caused by the builder and can be seen from a normal viewing position."

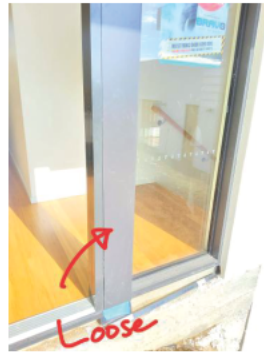
Photo 74

Window infill loose and not securely fixed in place.

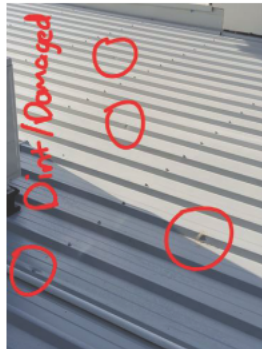
Photo 79

Numerous roof sheets have been creased and split open, these damaged sheets require replacement.

- (a) Do not use paint spray cans to touch up scratches.
- (b) If you cannot see the scratch from the ground, balcony, window, leave it alone.
- (c) If damage is severe, the sheets in questions are to be replaced."

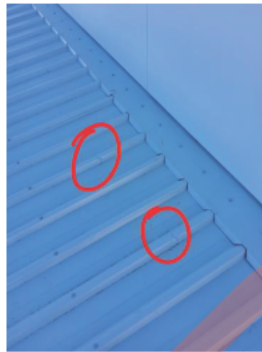
Photo 82

The VBA's Guide to Standards and Tolerance's section 6.02 states "Staining, folds, splits, dents, open joints between panels, cracking and other distortions in roof cladding is defective if it is visible from a normal viewing position at ground level or an upper floor level."

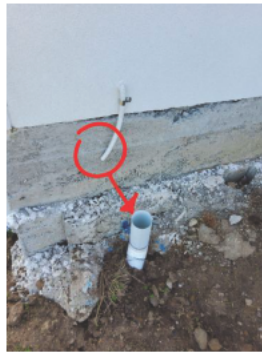
Photo 117

Refer to the VBA's Technical Solution Sheet 7.08, 7: Mechanical Services (Including duct heating) which informs practitioners on the requirements for the safe discharge of condensate from split system air-conditioners, and the secure fixing of condenser units. Refer to page 2 that notes: "The surface must be graded away from the building so that ponding does not occur, and the discharge does not present a safety risk to pedestrians (e.g. across a footpath), nor cause damage to buildings by changing moisture conditions."

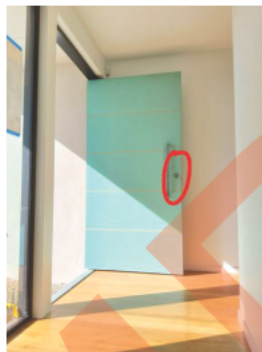
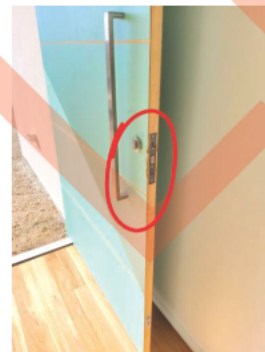
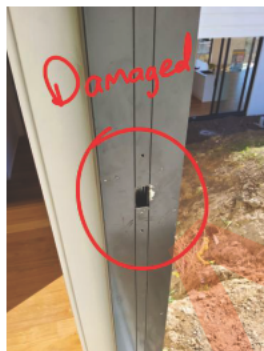
Entry door not painted and has been damaged.

Aluminium door frame damaged.

Refer to the VBA's Guide to Standards and Tolerances section 10.06 Manufactured material:
"Any cracking, displacement, pitting or similar blemishes in surfaces of manufactured materials are defective if they are caused by the builder and can be seen from a normal viewing position."

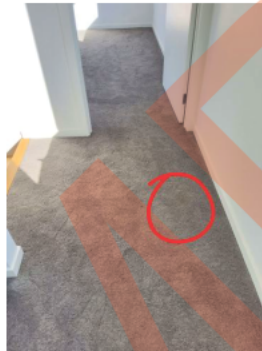
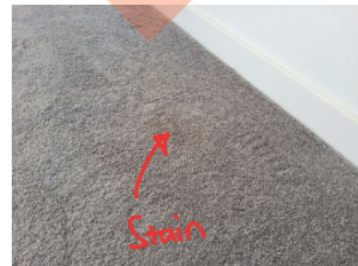
Stain on carpet.

Refer to the VBA's Guide to Standards and Tolerances section 10.06 Manufactured material: "Any cracking, displacement, pitting or similar blemishes in surfaces of manufactured materials are defective if they are caused by the builder and can be seen from a normal viewing position."

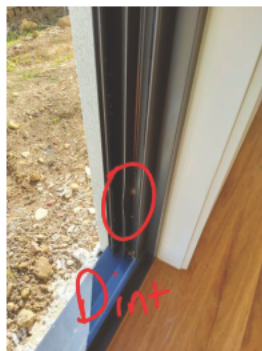
Window frame damaged.

Refer to the VBA's Guide to Standards and Tolerances section 10.06 Manufactured material: "Any cracking, displacement, pitting or similar blemishes in surfaces of manufactured materials are defective if they are caused by the builder and can be seen from a normal viewing position."

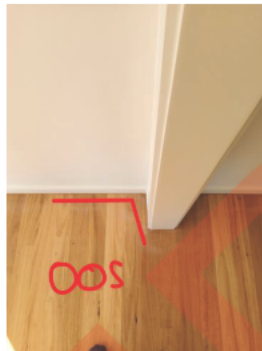
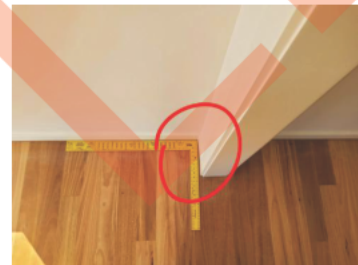
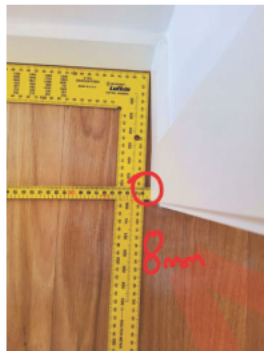
"Walls are defective if they deviate from plane (bow) by more than 5 mm over a 1.8 m straight edge. This tolerance includes internal walls with a build-up of plaster at internal and external corners of the plasterwork. Refer to Diagram E on page 13..." (of the VBA's Guide)

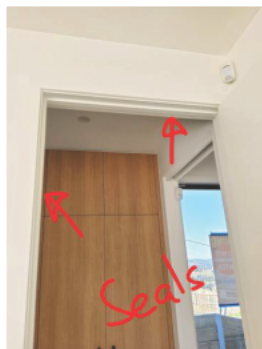
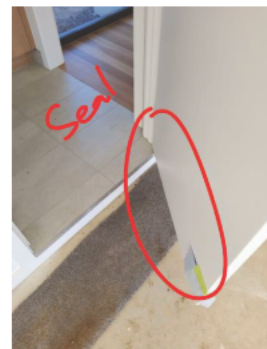
The Building Code of Australia Volume 2, Part 3.12.3.3 External windows and doors:
 "(a) An external door, internal door between a Class 1 building and an unconditioned Class 10a building, openable window and other such opening must be sealed when serving—
 (i) a conditioned space; or
 (ii) a habitable room in climate zones 4, 5, 6, 7 and 8.
 (b) A seal to restrict air infiltration—
 (i) for the bottom edge of a door, must be a draft protection device; and
 (ii) for the other edges of a door or the edges of an openable window or other such opening, may be a foam or rubber compressible strip, fibrous seal or the like."

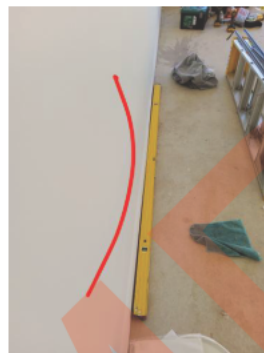
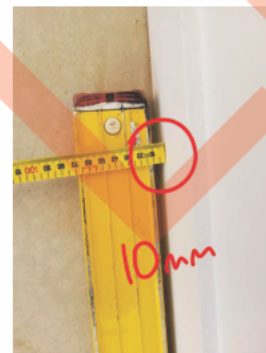
Refer to the VBA's Guide to Standards and Tolerances section 9.02 Straightness of internal and external wall surfaces:

"Walls are defective if they deviate from plane (bow) by more than 5 mm over a 1.8 m straight edge. This tolerance includes internal walls with a build-up of plaster at internal and external corners of the plasterwork. Refer to Diagram E on page 13..." (of the VBA's Guide)

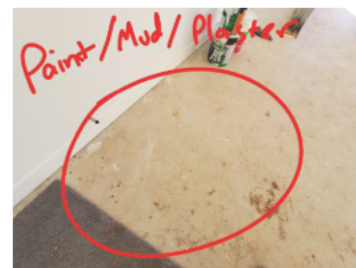
6.13.7: Floor clean

Refer to the VBA's Guide to Standards and Tolerances section 18.08 Cleaning:
 "Owners are entitled to expect that the building site and works are clean and tidy on completion. Where handover is delayed for any reason the owner must expect that dust may have settled on interior exposed surfaces.
 Building sites are defective if they are not clear of building debris.
 Building works are defective where windows are not clean, floors are not swept, mopped or vacuumed as appropriate, tiles, sinks, basins, troughs, baths, etc. are not cleaned, and shelving, drawers and cupboards ready for use."

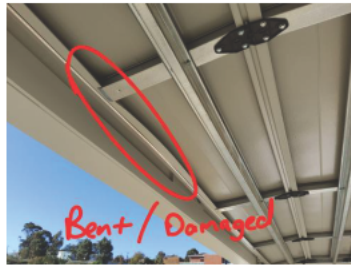
Bottom edge of garage door appears to be bent / damaged.

Refer to the VBA's Guide to Standards and Tolerances section 10.06 Manufactured material:
 "Any cracking, displacement, pitting or similar blemishes in surfaces of manufactured materials are defective if they are caused by the builder and can be seen from a normal viewing position."

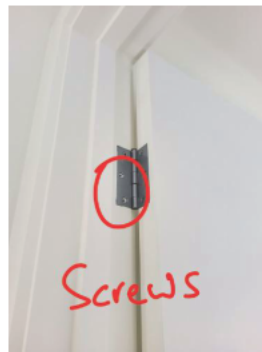
Screws missing from door hinges.

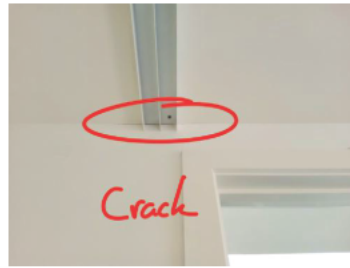
The VBA's Guide to Standards and Tolerances section 9.14 Cracking in plasterboard, hard plaster and other plaster elements:

"Cracking in walls, ceilings and bulkheads is defective if it exists at handover or exceeds 1 mm in width within the first 24 months of completion and can be seen from a normal viewing position. Cracking in recessed and butt joints is defective if it exists at handover or exceeds 1 mm in width within the first 24 months of completion and can be seen from a normal viewing position."

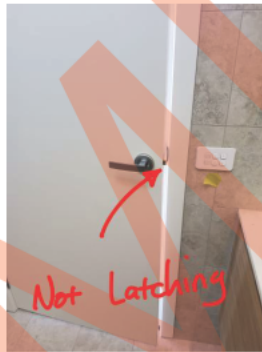
"During the documented maintenance period after completion, handles, locks and latches are defective if they do not operate as intended by the manufacturer. If the maintenance period is not documented, three months is the assumed time period after completion. After the end of the maintenance period, failure is not a defect unless it is caused by the builder's workmanship or a faulty product supplied by the builder."

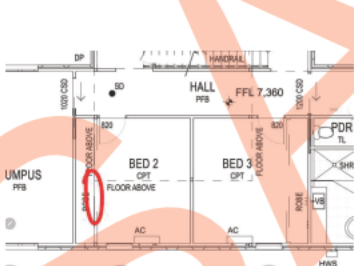
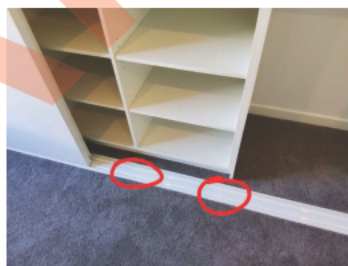
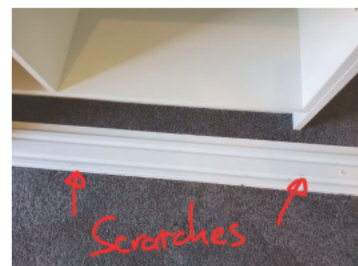
Refer to the VBA's Guide to Standards and Tolerances section 10.06 Manufactured material:

"Any cracking, displacement, pitting or similar blemishes in surfaces of manufactured materials are defective if they are caused by the builder and can be seen from a normal viewing position."

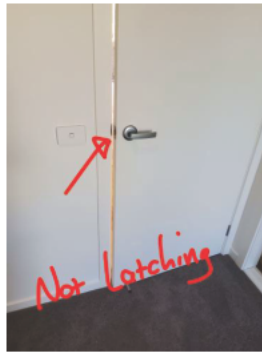
defective if they do not operate as intended by the manufacturer. If the maintenance period is not documented, three months is the assumed time period after completion. After the end of the maintenance period, failure is not a defect unless it is caused by the builder's workmanship or a faulty product supplied by the builder."

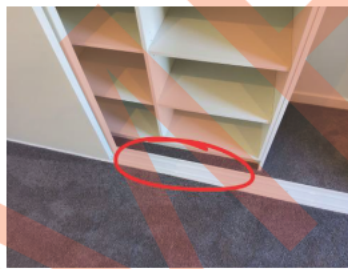
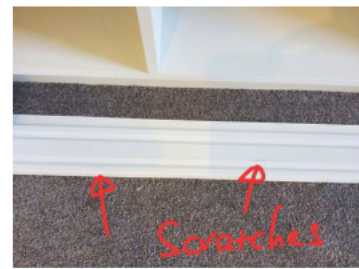
7.3.4: Wardrobe

Refer to the VBA's Guide to Standards and Tolerances section 10.06 Manufactured material: "Any cracking, displacement, pitting or similar blemishes in surfaces of manufactured materials are defective if they are caused by the builder and can be seen from a normal viewing position."

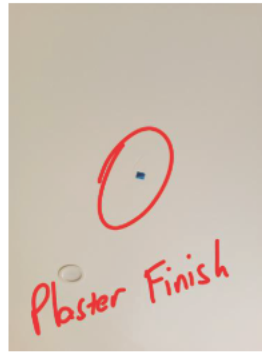
Photo 185

8.1.8: Plastering; walls/ceiling/cornice (Cracking, bow, finish)

DEFECT

Refer to the VBA's Guide to Standards and Tolerances section 9.13 Level of finish for plasterboard: "Unless documented otherwise, a plasterboard finish is defective if Level 4 finish (as defined below) is not provided: A Level 4 finish shall be the default level for gypsum lining, unless specified otherwise. Flat or low sheen paints shall be used for this Level 4. All joints and interior angles shall have tape embedded in jointing cement/jointing compound and a minimum of two separate coats of jointing cement/jointing compound applied over all joints, angles, fastener heads and accessories. All jointing compound shall be finished evenly and be free of tool marks and ridges in preparation for decoration."

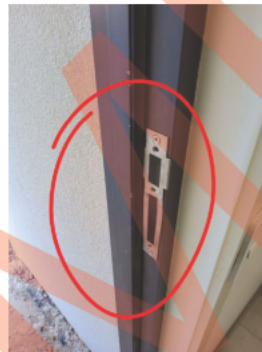
Photo 187

DEFECT

Door frame damaged.

Refer to the VBA's Guide to Standards and Tolerances section 10.06 Manufactured material: "Any cracking, displacement, pitting or similar blemishes in surfaces of manufactured materials are defective if they are caused by the builder and can be seen from a normal viewing position."

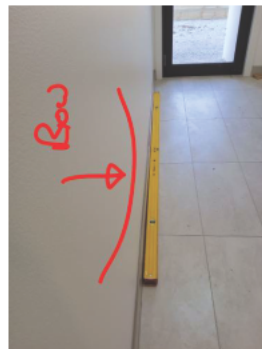
Photo 190

8.3.6: Plastering; walls/ceiling/cornice (Cracking, bow, finish)

DEFECT

"Walls are defective if they deviate from plane (bow) by more than 5 mm over a 1.8 m straight edge. This tolerance includes internal walls with a build-up of plaster at internal and external corners of the plasterwork. Refer to Diagram E on page 13..." (of the VBA's Guide)

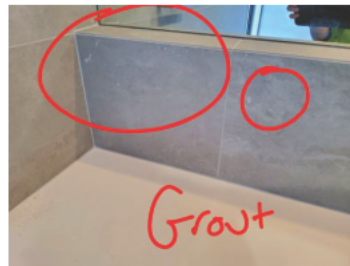
Photo 193

8.5.14: Wall finishes; workmanship, damaged tiles, grout inconsistent etc

DEFECT

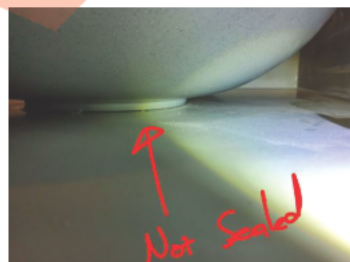
Photo 195

DEFECT

"Where required, junctions between bench tops and adjoining surfaces are defective if they are not sealed with a suitable flexible sealant of matching or agreed colour. Seals around items such as sinks, hand basins or the like are defective if the joint leaks or they are not installed in accordance with the manufacturer's installation requirements."

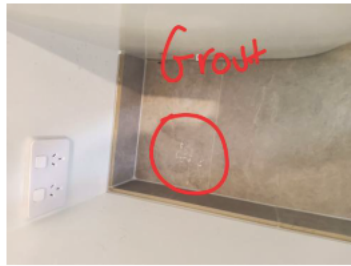
Photo 198

+8.6.6: Floor; Tiling; workmanship, damaged tiles, grout inconsistent etc

DEFECT
